# License Plate Lamp Not ON

For a 2007 BENZ VIANO commercial car, with mileage of 20,000km, the license plate lamp cannot light up.

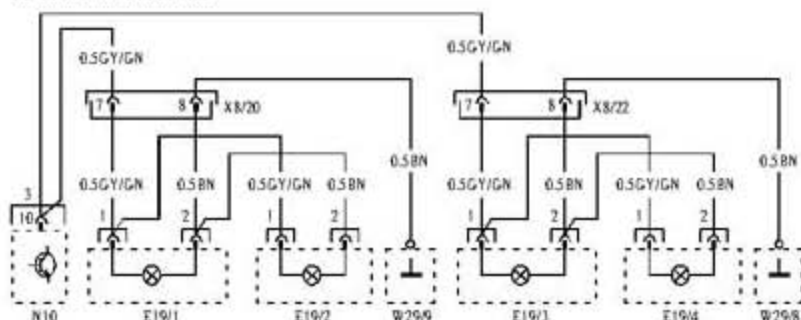
- 2) Firstly check the bulb of rear license plate lamp, it's OK. After testing by diagnostic tool, it displays a fault code stored in SAM module indicating positive circuit short or open. According to the circuit diagram (figure), E19/1 and E19/2 in the figure are rear license plate lamps. Use multimeter to test the grounding of rear license plate lamp and it is OK. Then test the supply voltage, no voltage. As the rear tail lights E19/3 and E19/4 can light up normally, it is deduced the fault point locates in the circuit between N10 and license plate lamp in SAM module. As indicated in the circuit diagram, there's a harness plug-in between SAM module and license plate lamp. It is possible this plug failed. Thus, we check this plug first. Remove the rear right plaque and rear right tail light to check the harness plug-in X8/20. The plug is corroded and there's water in the circuit. By further check, it is found the rear windshield washing pipe breaks off. When washing the windshield, the detergent would spout to the circuit, which caused the corrosion.

It seems like a simple fault of license plate lamp, but after checking, it is unexpectedly the problem of circuit corrosion which caused by broken washing pipe. Even if it's a simple fault, we shall check carefully to find out the source and solve the problem completely.

- 3) After repair the washing pipe, the fault is successfully removed.
