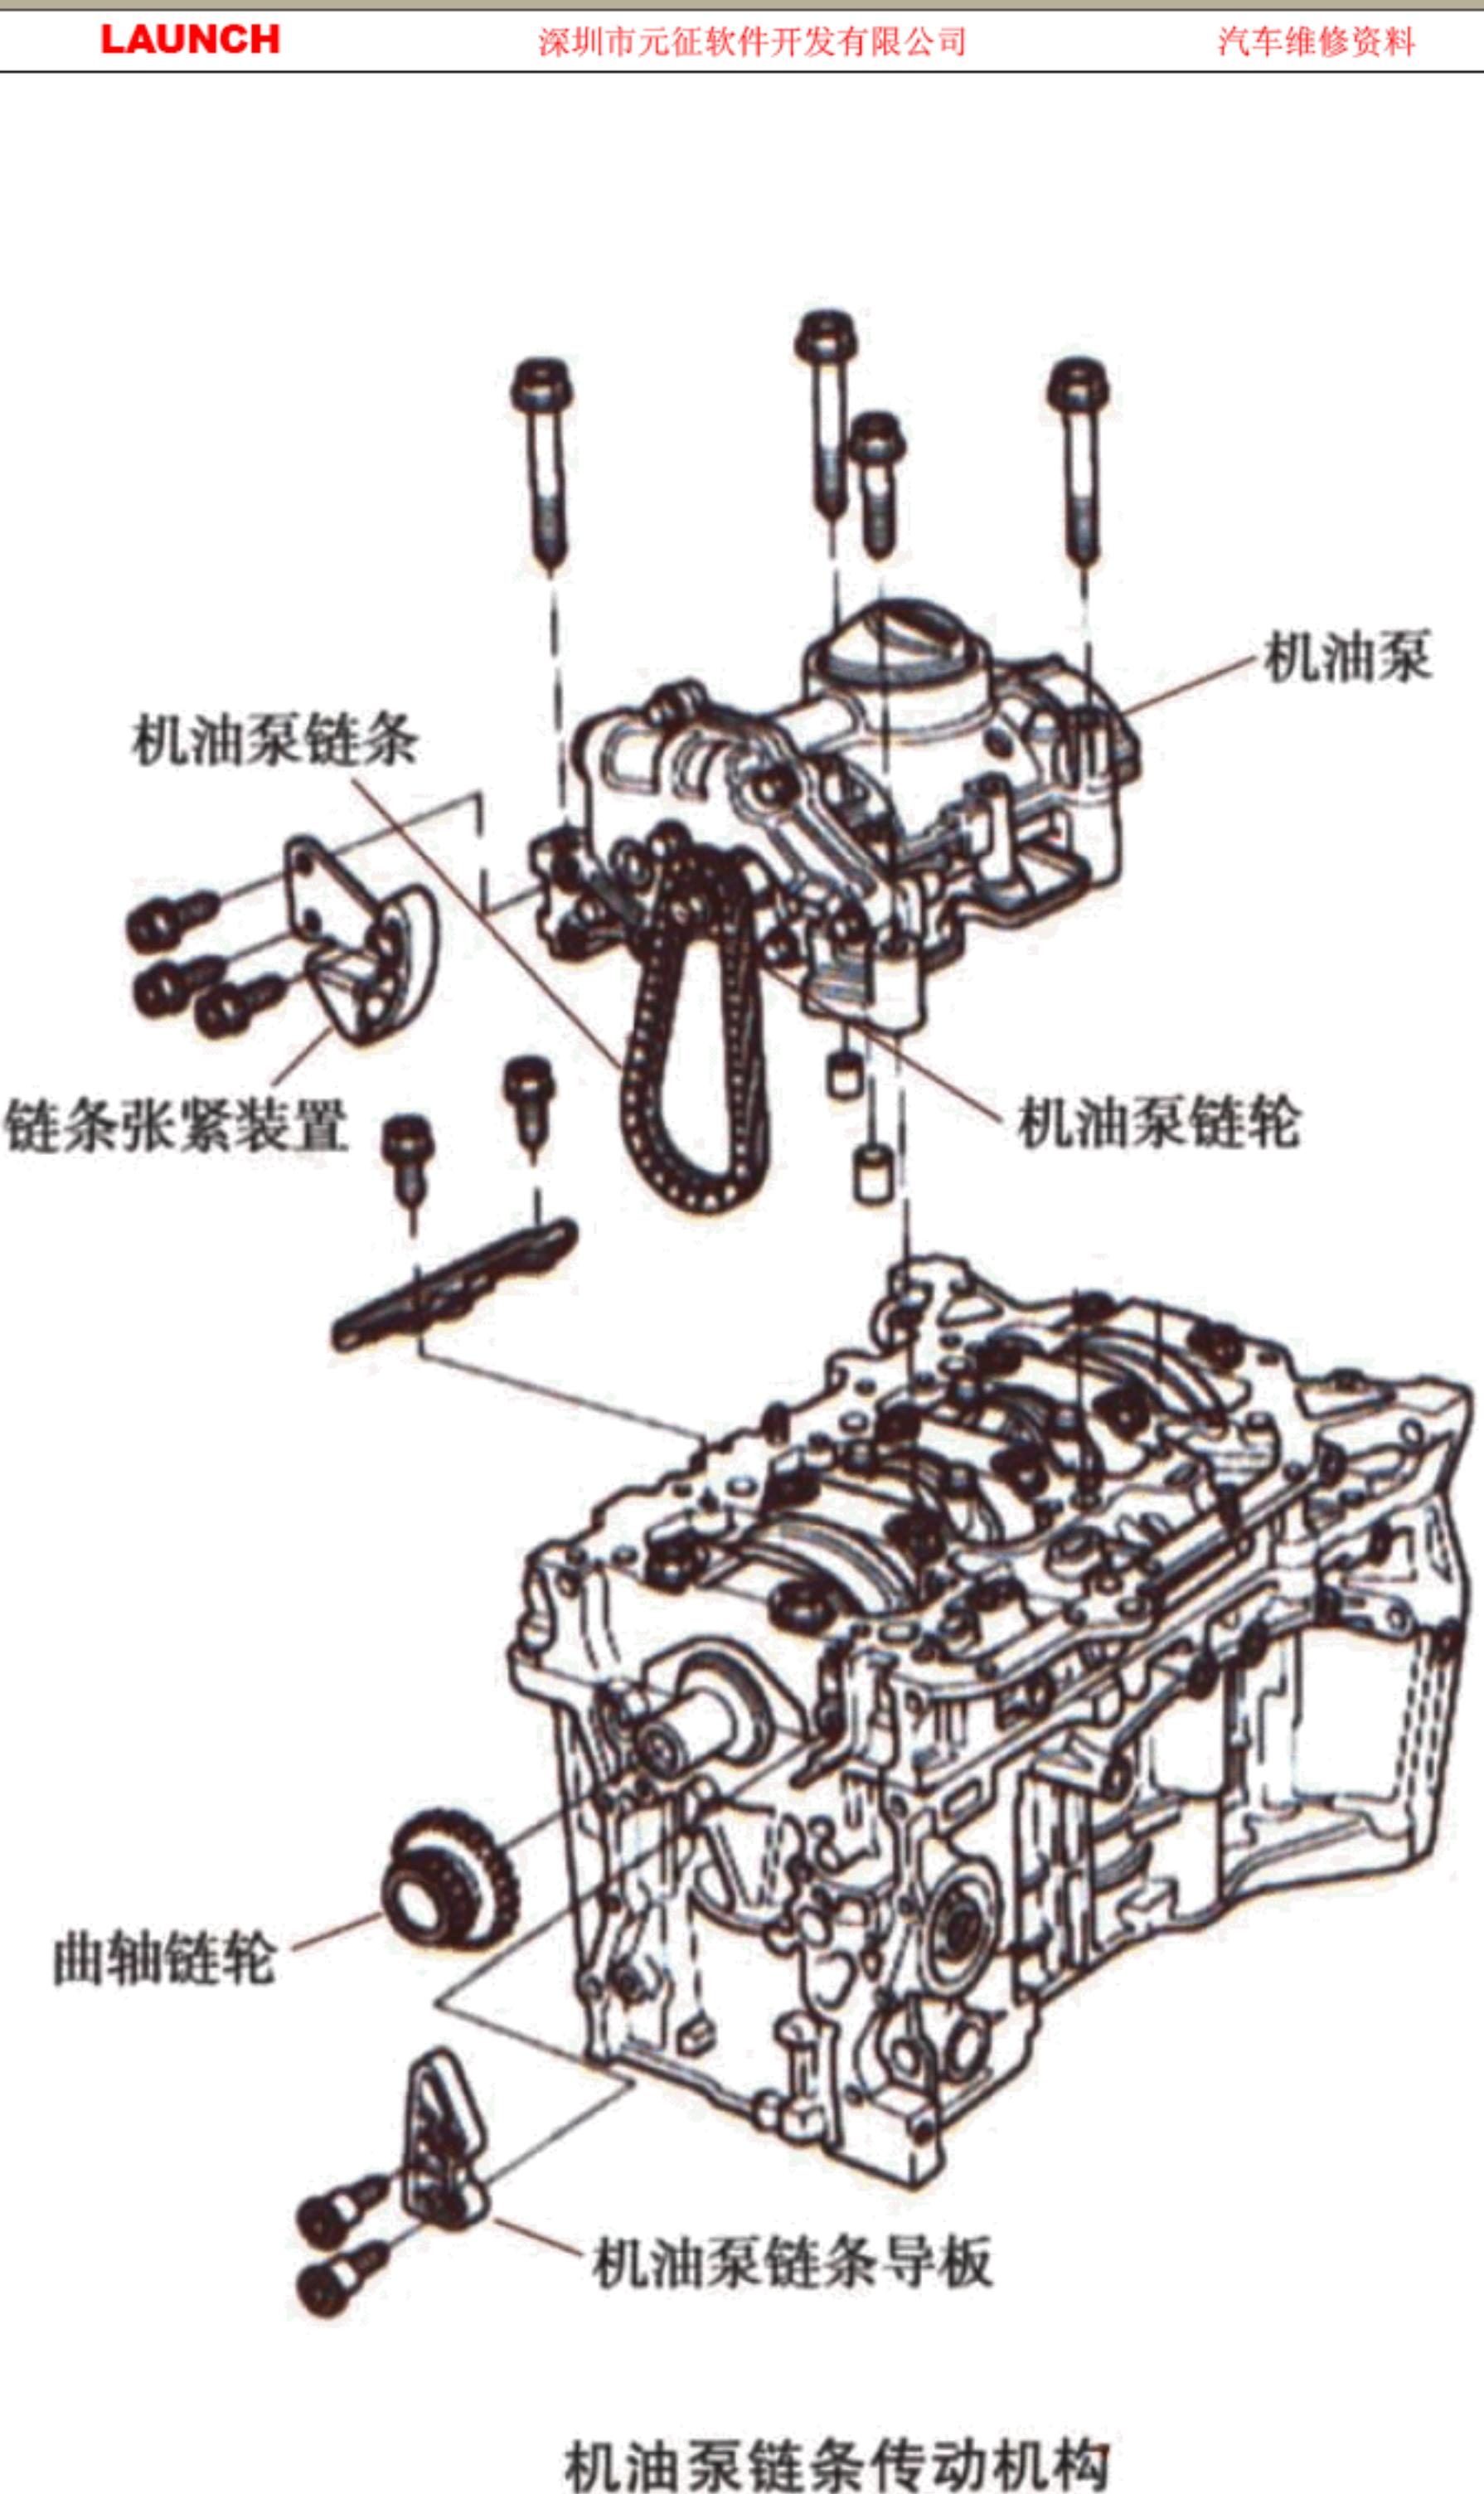
发动机内部曲轴传动轮附近的主要机构为发动机正时链条传动机构和机油泵链条传动机构（见下面二图）。发动机正时链条传动机构主要由曲轴链轮、凸轮轴链轮、正时链条、链条导板、链条张紧装置等部件组成，这些部件安装在曲轴及曲轴以上的发动机气缸体及气缸盖上。机油泵链条传动机构主要由曲轴链轮、机油泵链轮、机油泵链条、链条导板、链条张紧装置等部件组成，这些部件安装在曲轴及曲轴以下的发动机气缸体及机油泵壳上。其中，曲轴链轮为主动部件，凸轮轴链轮和机油泵链轮为从动部件，正时链条和机油泵链条为传动部件，链条导板和链条张紧装置的作用是减小链条的振幅及传动噪音，以保证链条传动平稳。由此推断，发动机正时链条传动机构或机油泵链条传动机构的链条导板或链条张紧装置损坏。与驾驶人沟通得知，该车发动机正时链条传动机构已在行驶里程达 20 万 km 时更换过，进一步推断机油泵链条传动机构的链条导板或链条张紧装置损坏的可能性较大，于是决定先拆检机油泵链条传动机构。拆下油底壳，发现机油泵链条导板掉在了油底壳中，进一步检查发现，机油泵链条张紧装置上的动臂已损坏脱落，失去了张紧作用，导致机油泵链条搭落在链条张紧装置的固定架上。
