2011 Prado ABS DTC "C120a, ECU Initialization Not Completed" Rectifying Method

Product Model	Date	Number
X431Pro series	20160419	—

- Toyota Prado, 2011, VIN= JTEJU3FJXB50*****

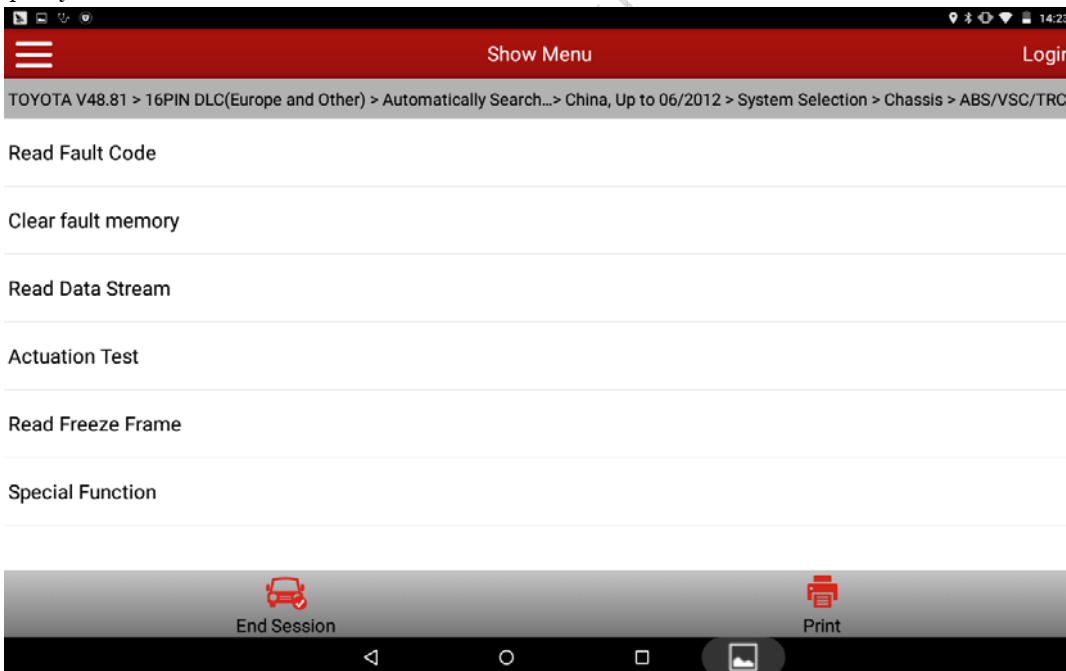
- 10). Read the DTC. The information "C120a, ECU initialization is not completed" is displayed.

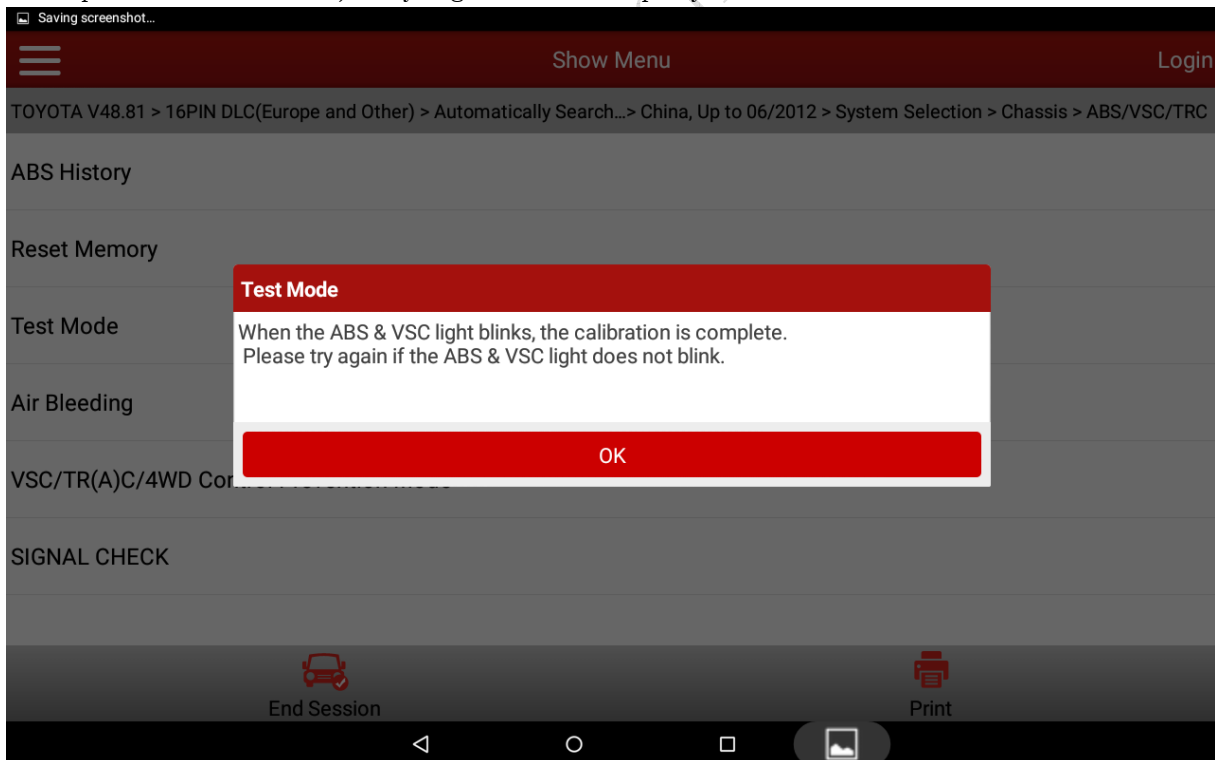
18). The message "When the ABS&VSC lamp blinks, calibration is complete. If the ABS&VSC lamp does not blink, try again" is displayed.
