2007 Mercedes-Benz S600 Front-Passenger Seat Occupancy Recognition Troubleshooting

Tested Model: 2007 Mercedes-Benz S600, VIN: WDDNG7AX37A14****, as shown below:

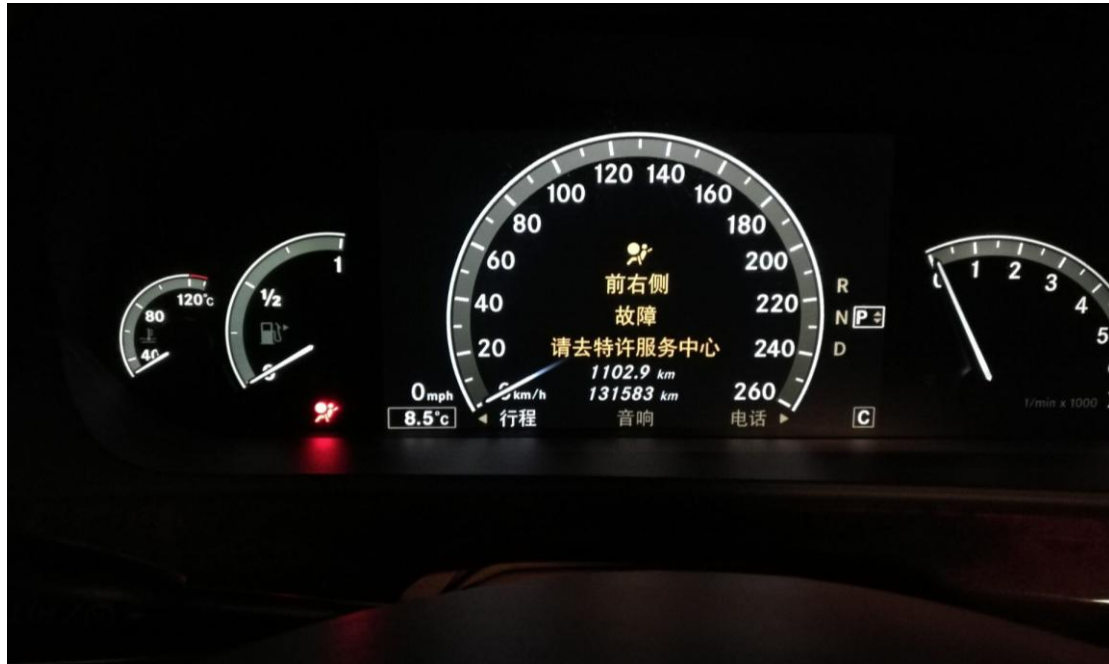
Picture 1

Engine instrument shows front right airbag error, see Picture 1.

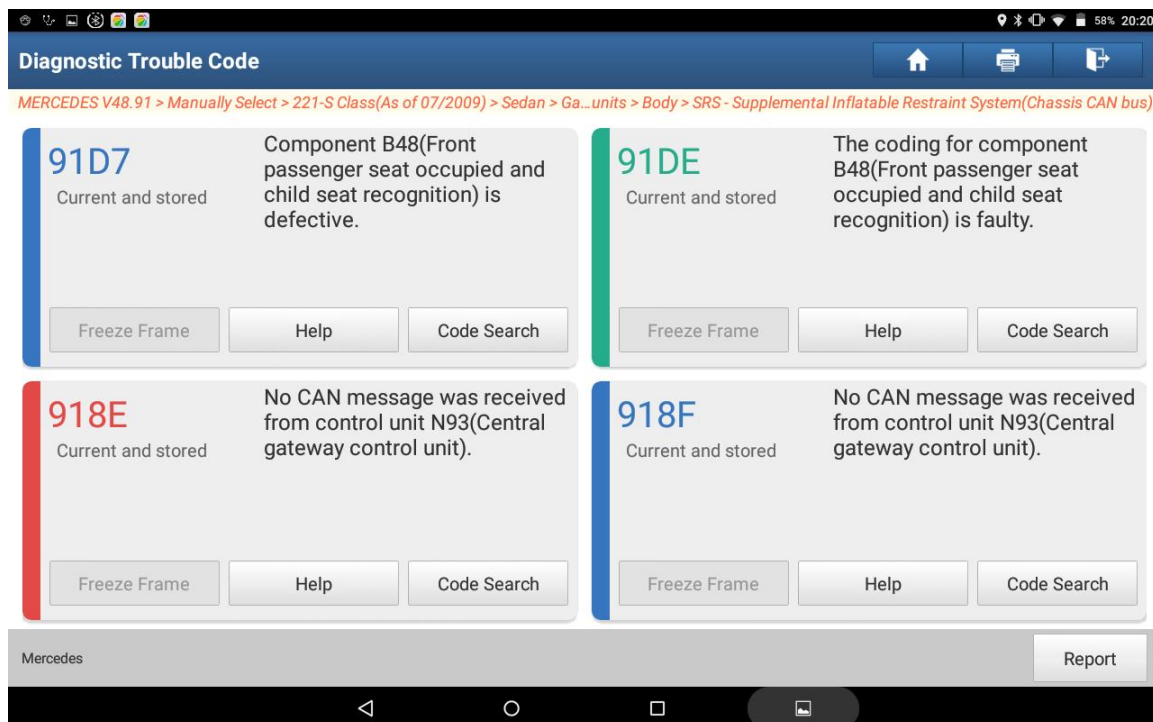
Picture 2

- 1) Enter the airbag system, turn on the ignition, click OK.
- 2) Read DTC. The fault code cannot be removed, see Picture 2.

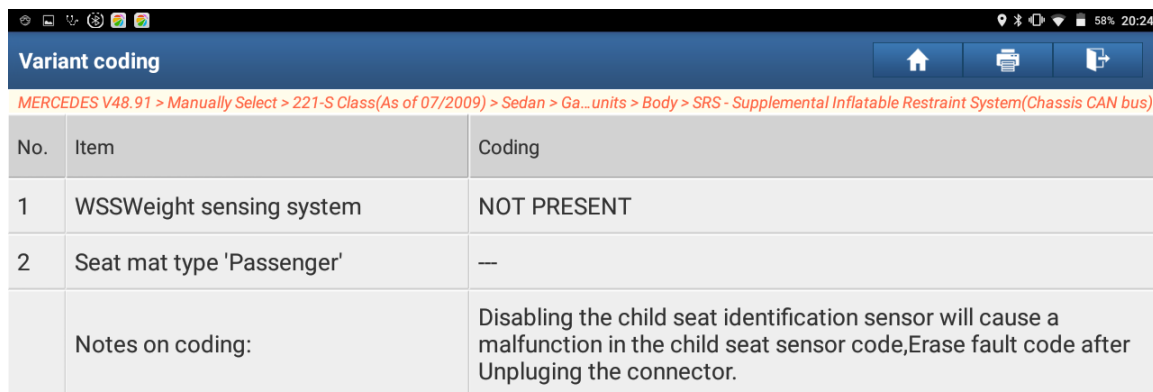
Picture 5

5) Item 1 & 2 show incorrect configuration, see Picture 5.

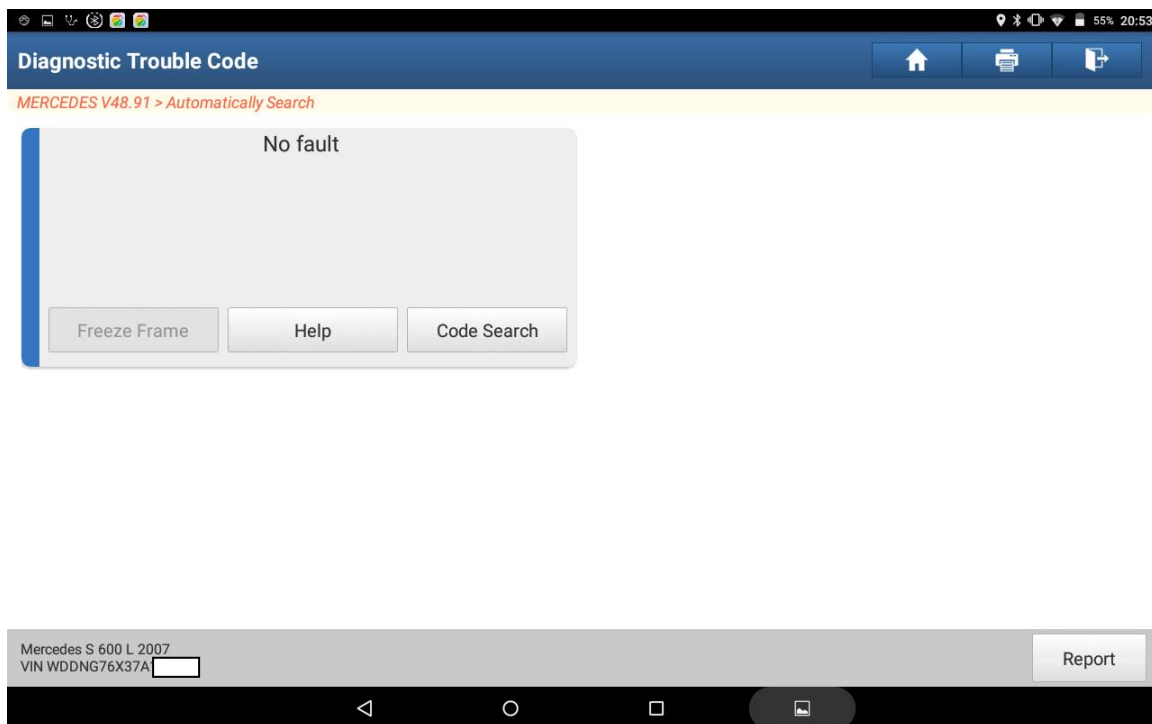
Picture 15

15) Return, the fault code can now be removed, see Picture 15.

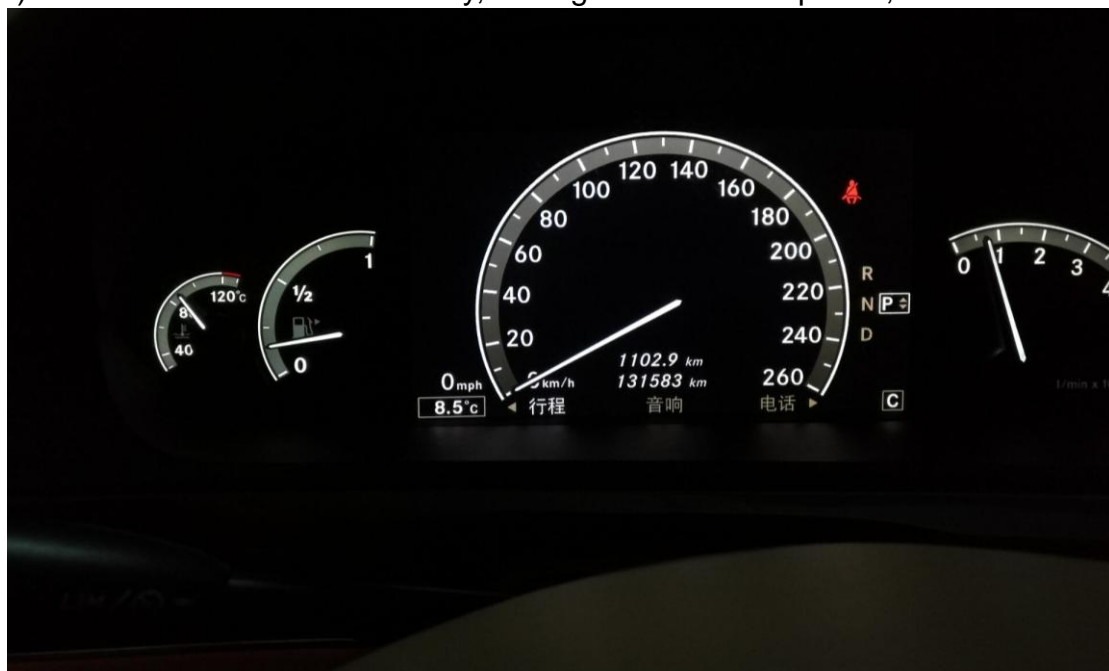
Picture 16

16) The instrument shows normally, coding has been completed, see Picture 16.
