51. 零组件图标 (31\73-54\21)

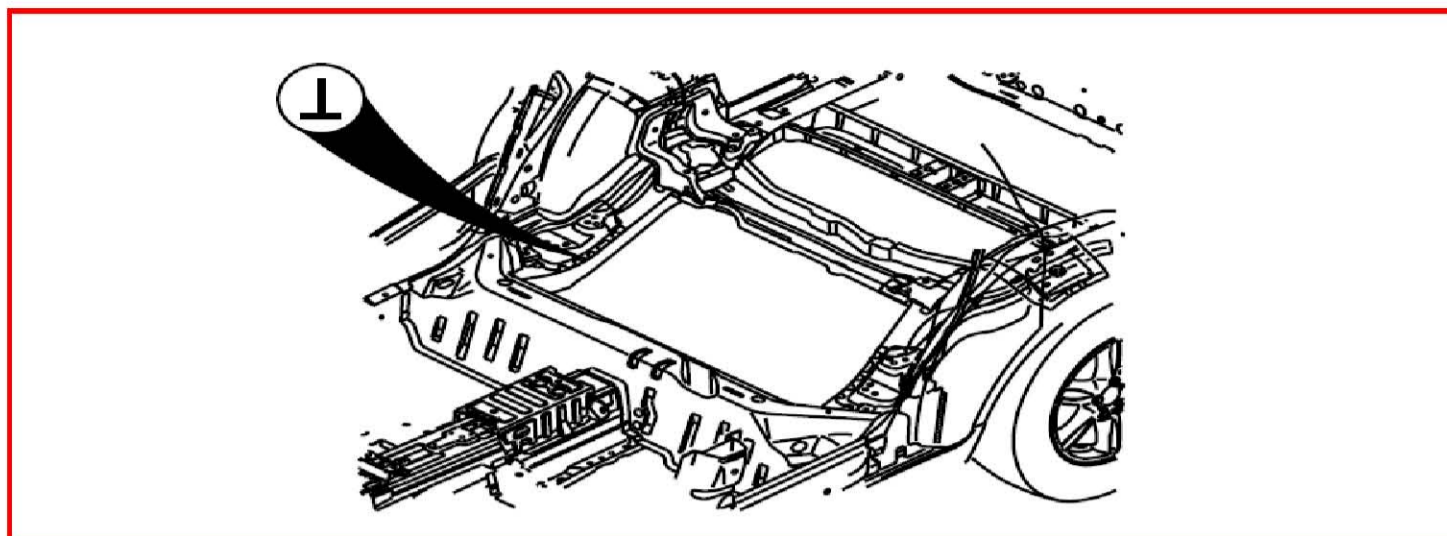
### 31/73 右後座椅升降機接地 XC90

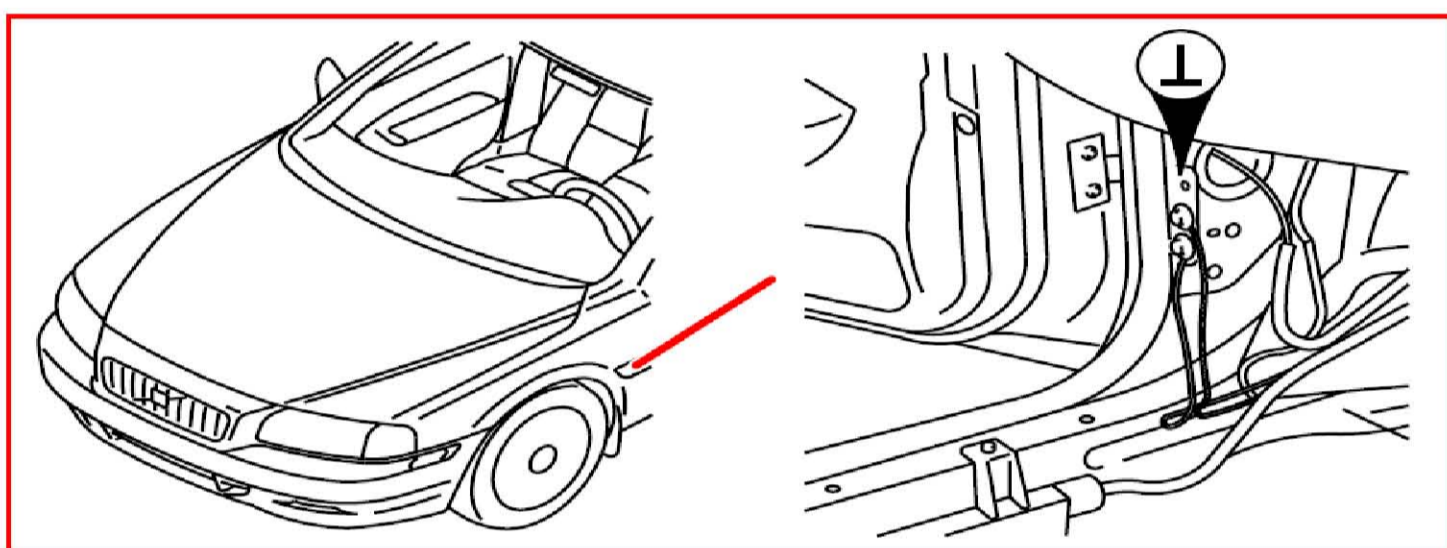
### 31/83 左側 A 柱接地 V70

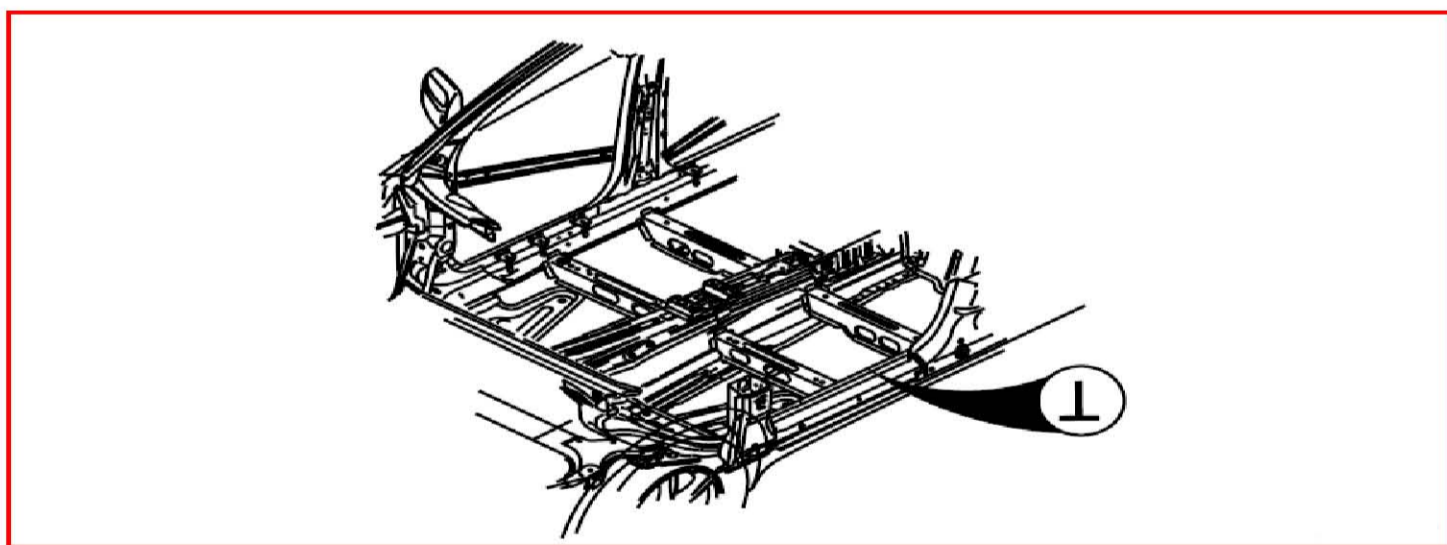
### 31/83 左側 A 柱接地 XC90

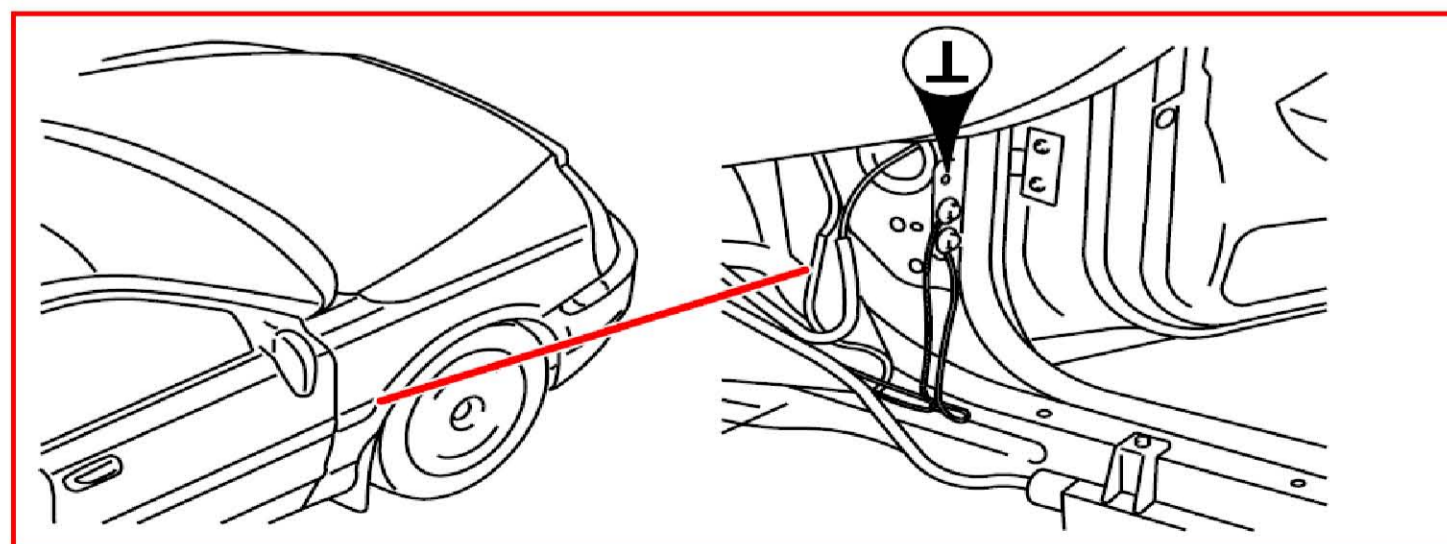
### 31/84 右側 A 柱接地 V70

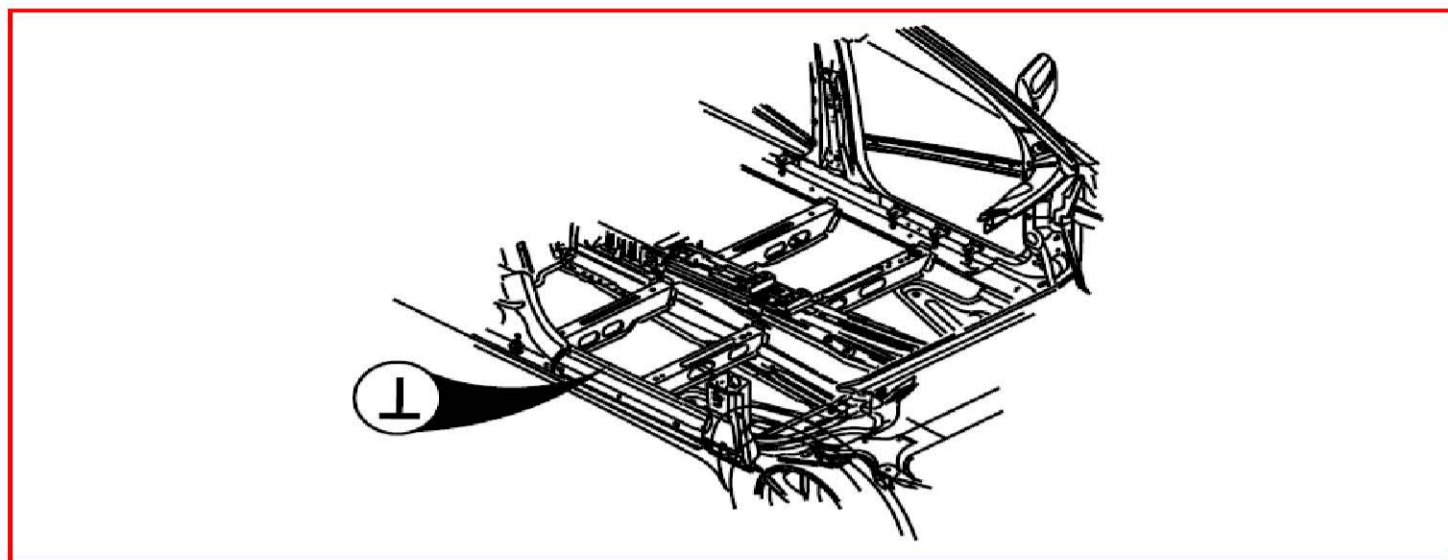
### 31/84 右側 A 柱接地 XC90

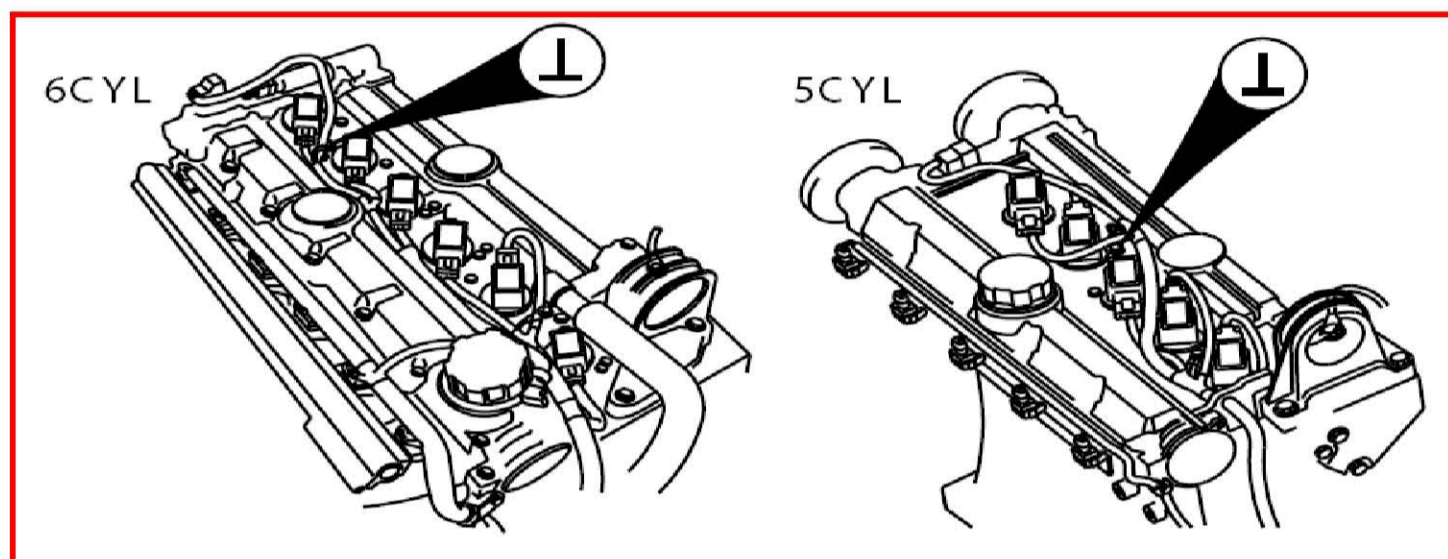
### 31/88 引擎點火線圈組 1 接地

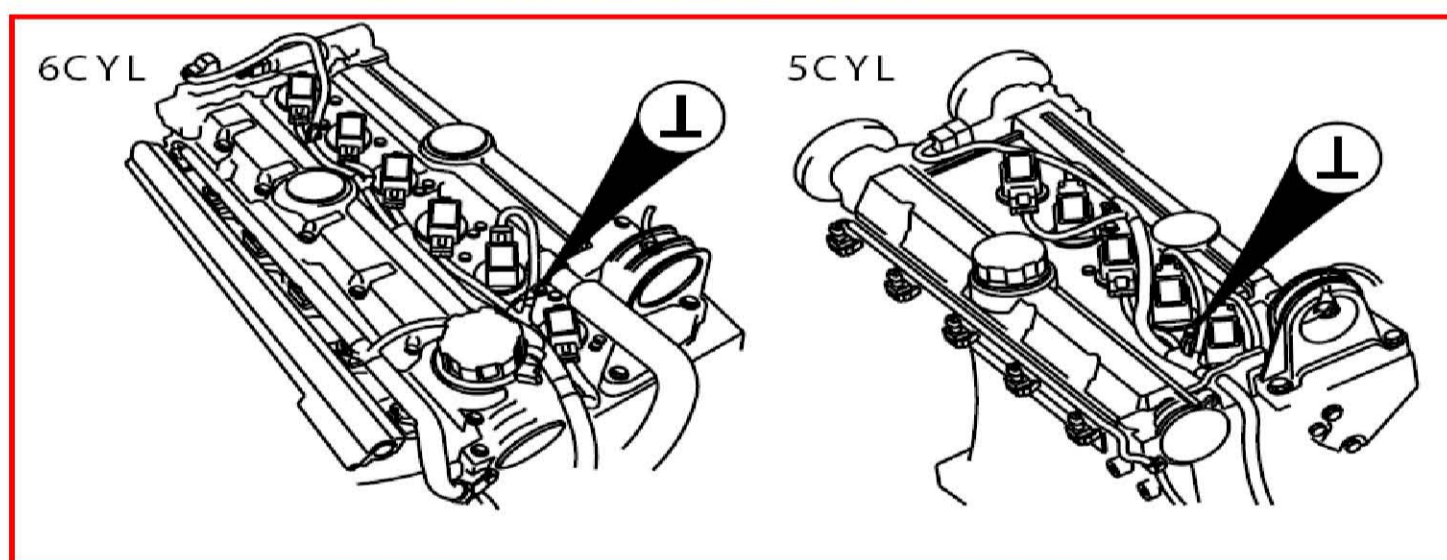
### 31/89 引擎點火線圈組 2 接地

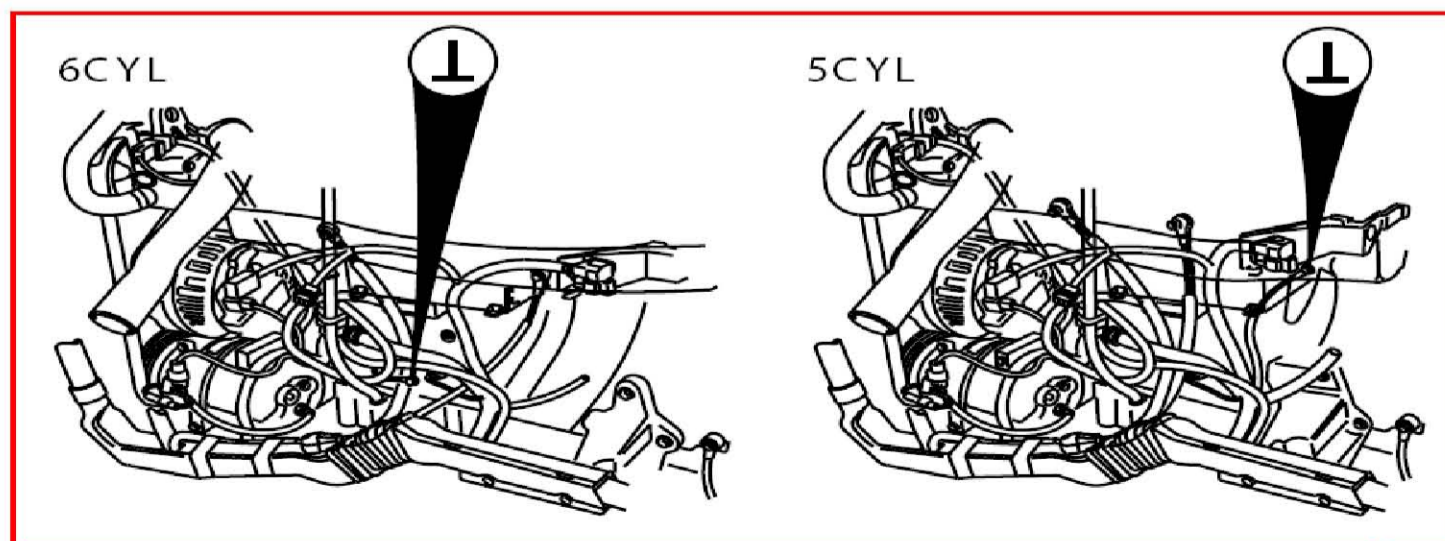
### 31/91 引擎接地

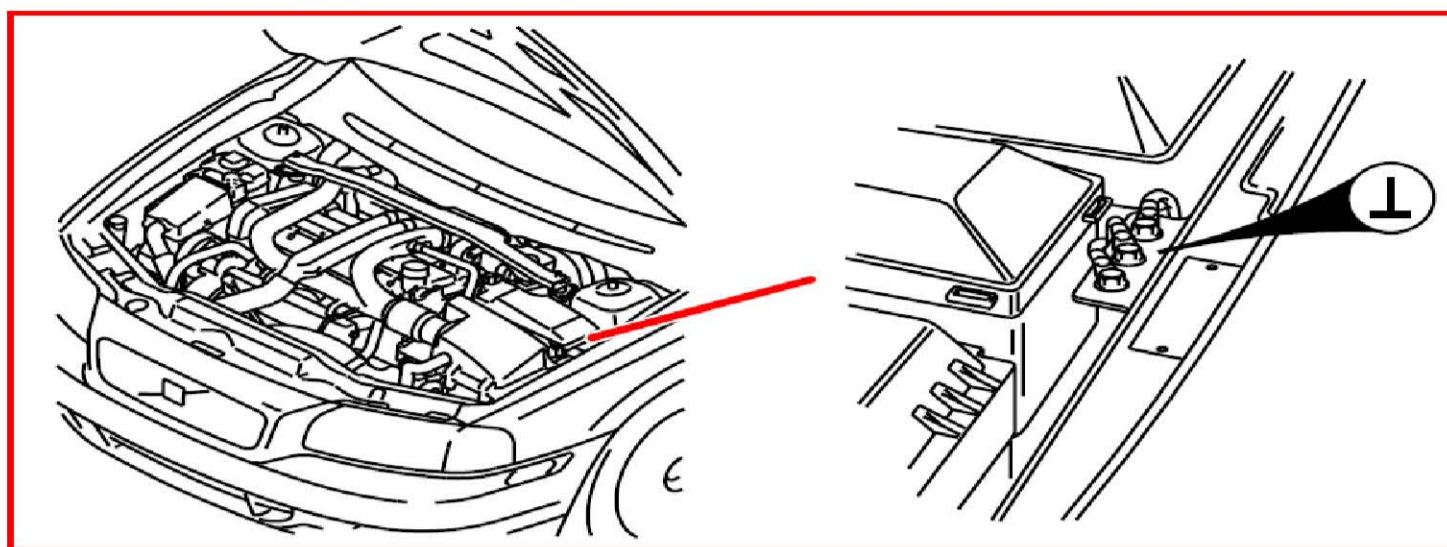
## 31/93 左麥花臣支柱接地 V70

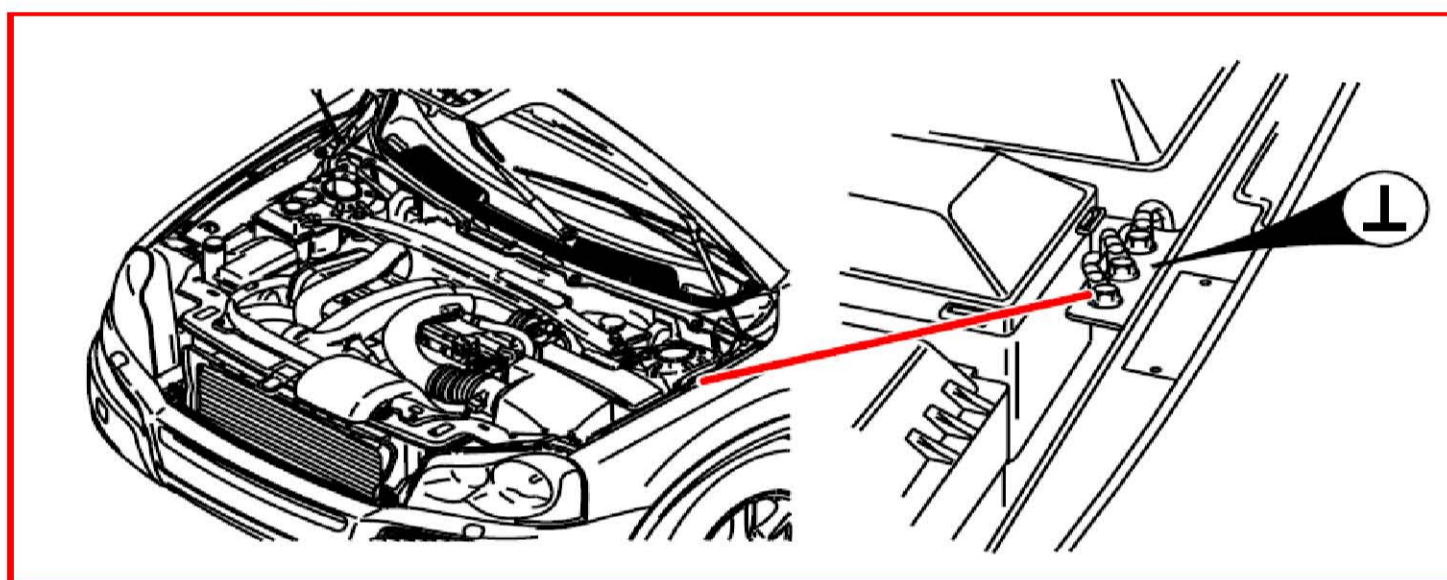
## 31/93 左麥花臣支柱接地 XC90

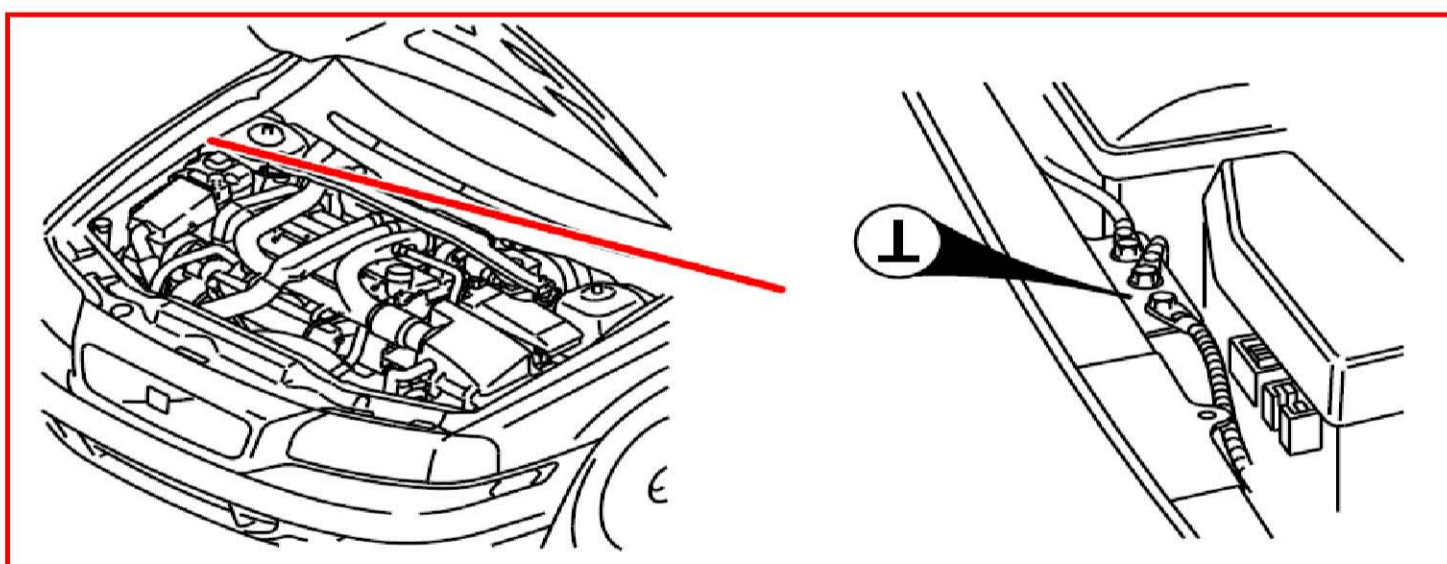
## 31/94 右麥花臣支柱接地 V70

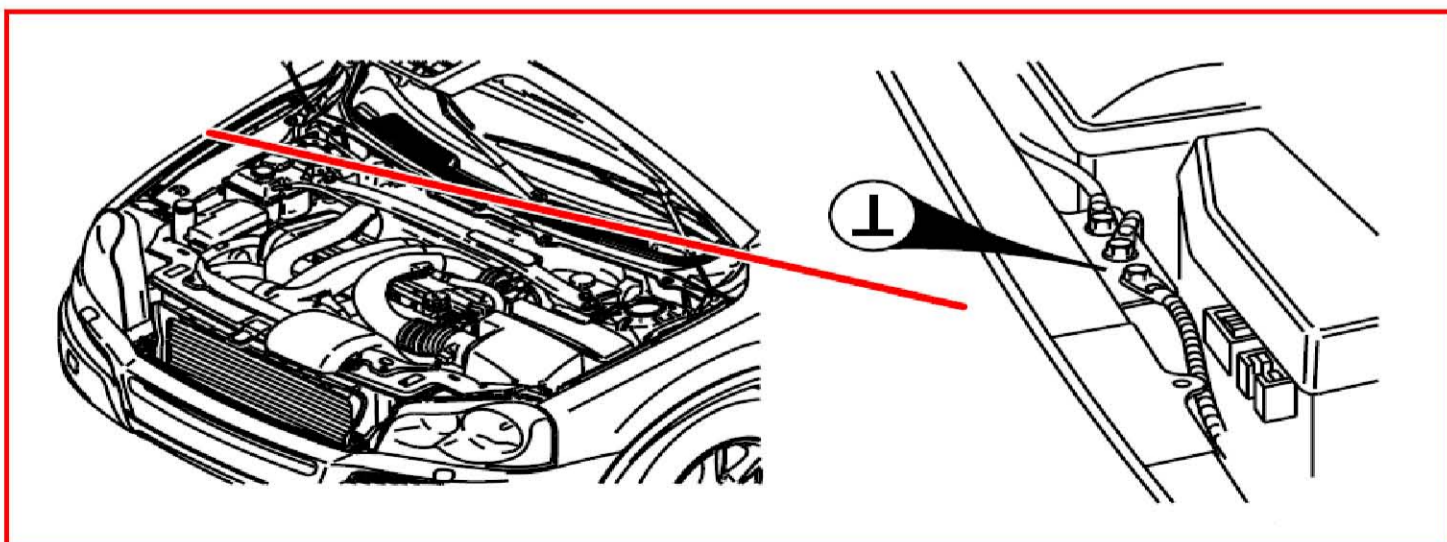
## 31/94 右麥花臣支柱接地 XC90

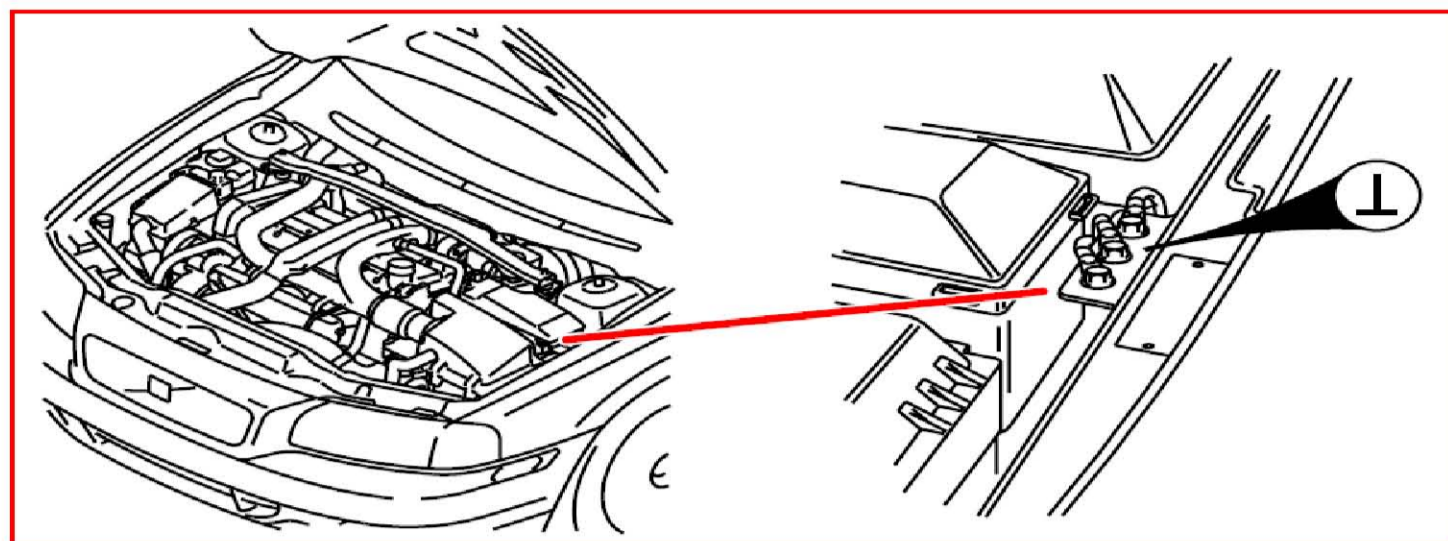
## 31/95 左麥花臣支柱接地 V70

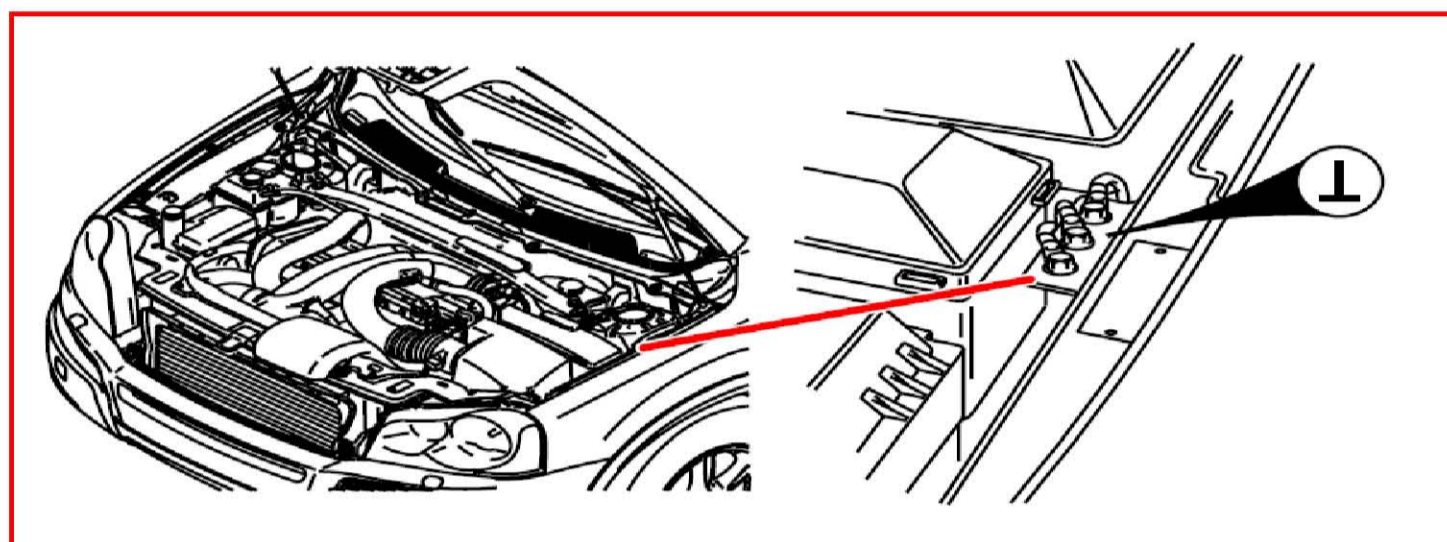
## 31/95 左麥花臣支柱接地 XC90

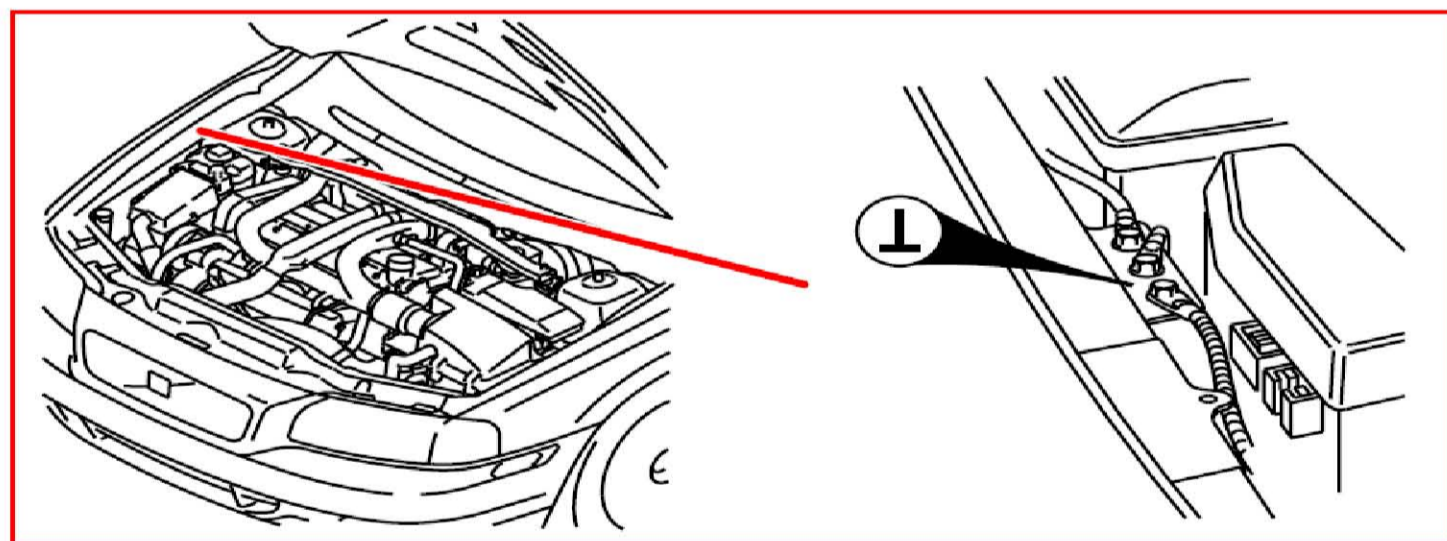
## 31/96 右麥花臣支柱接地 V70

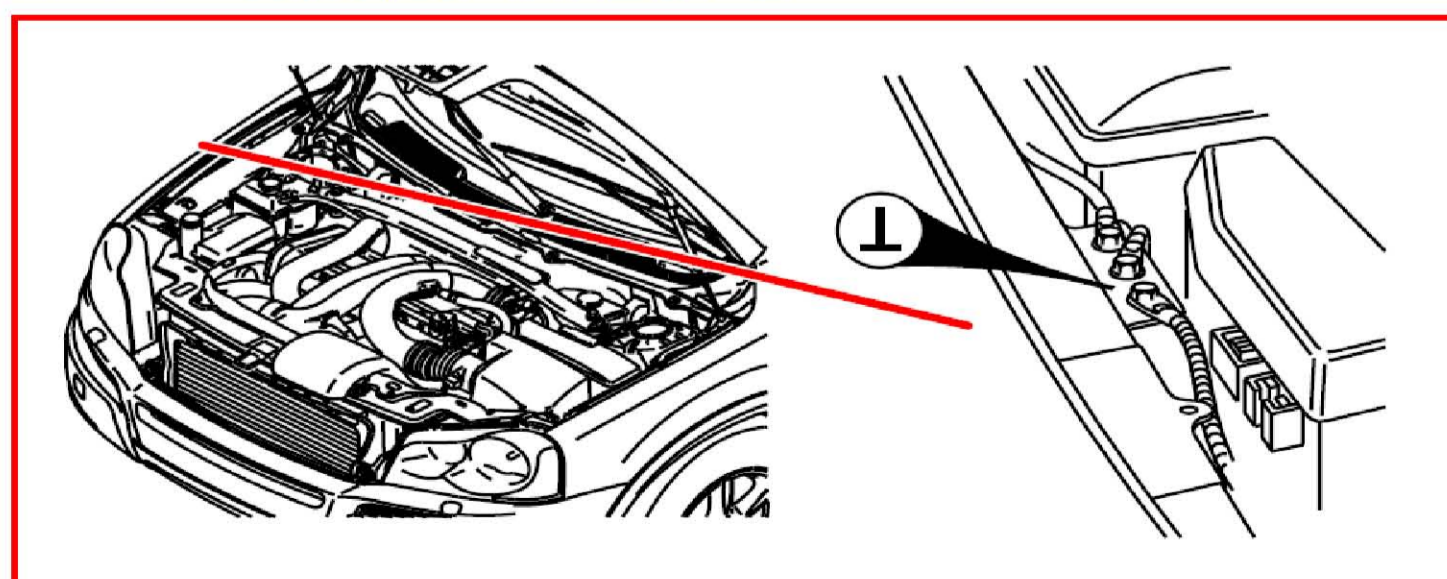
## 31/96 右麥花臣支柱接地 XC90

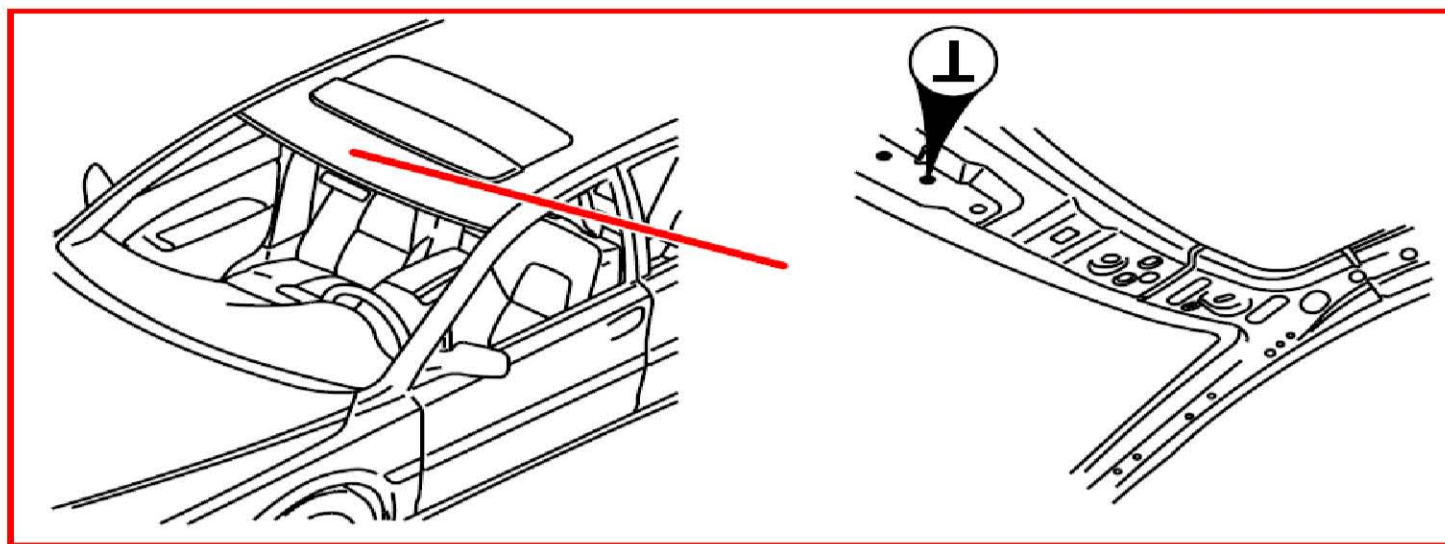
### 31/98 擋風玻璃上樑接地 V70

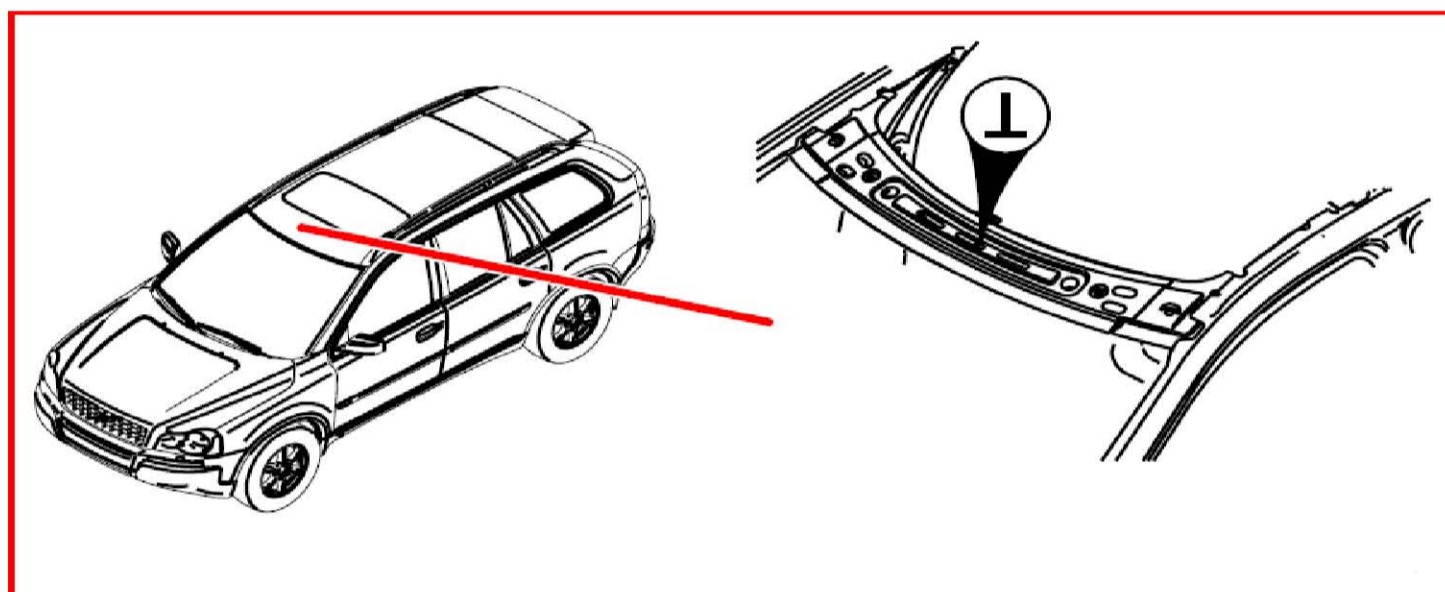
### 31/98 擋風玻璃上樑接地 XC90

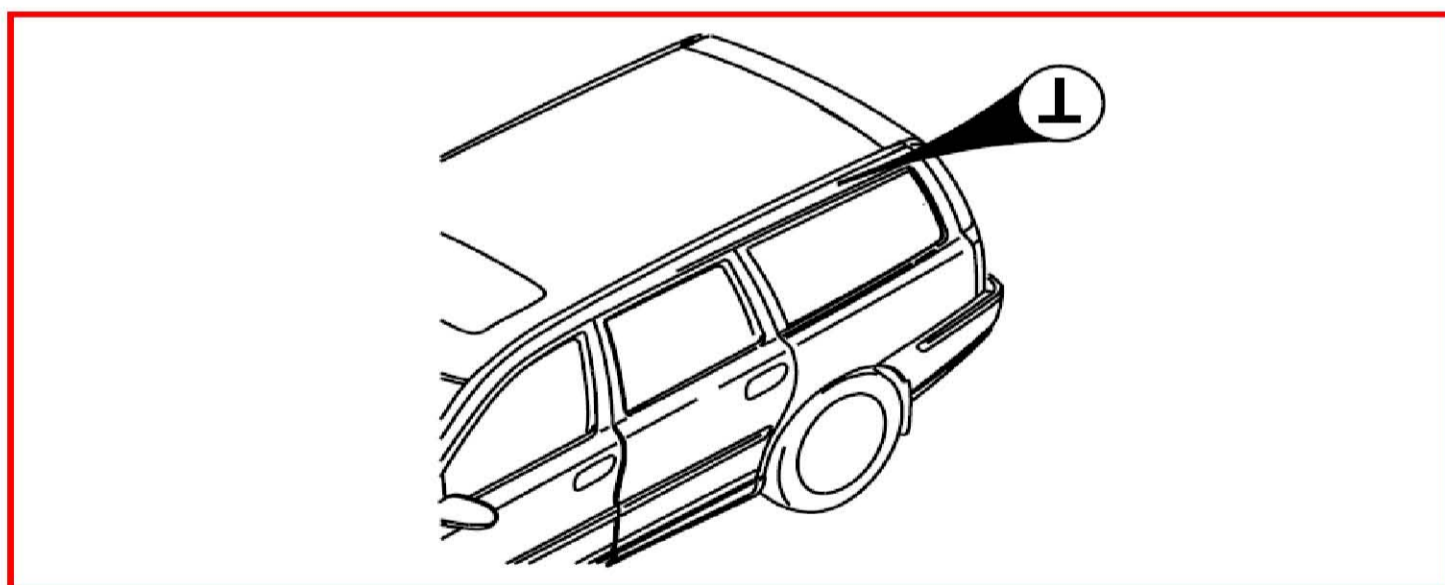
### 31/99 左側車窗接地

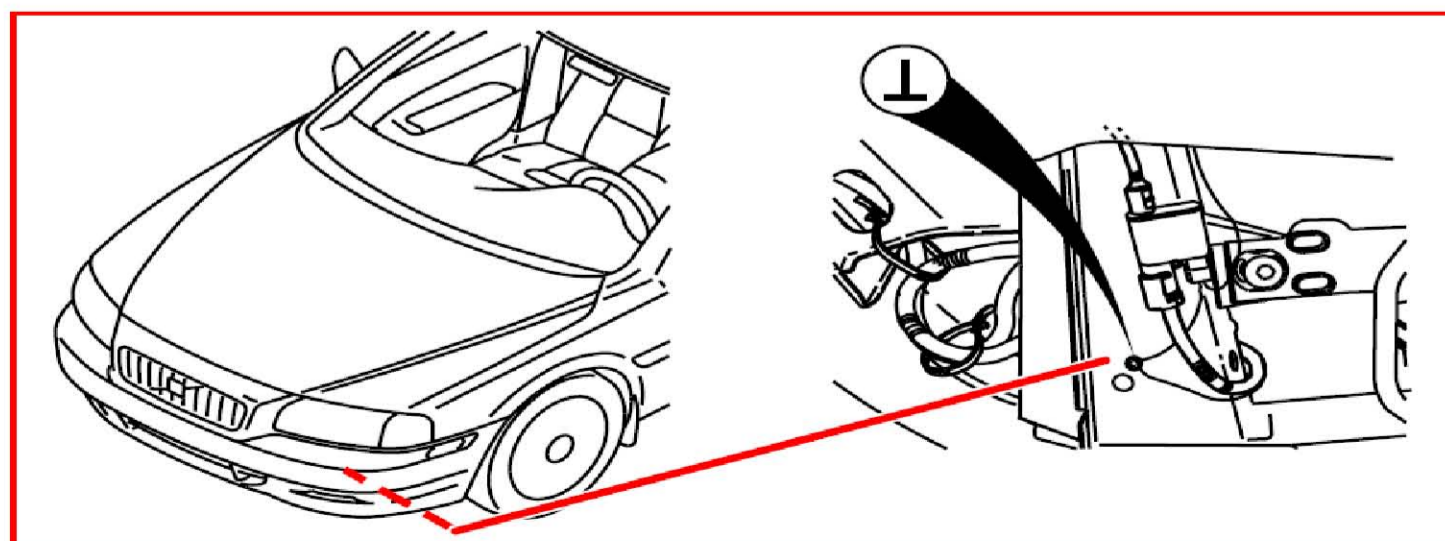
### 31/102 前樑接地 V70

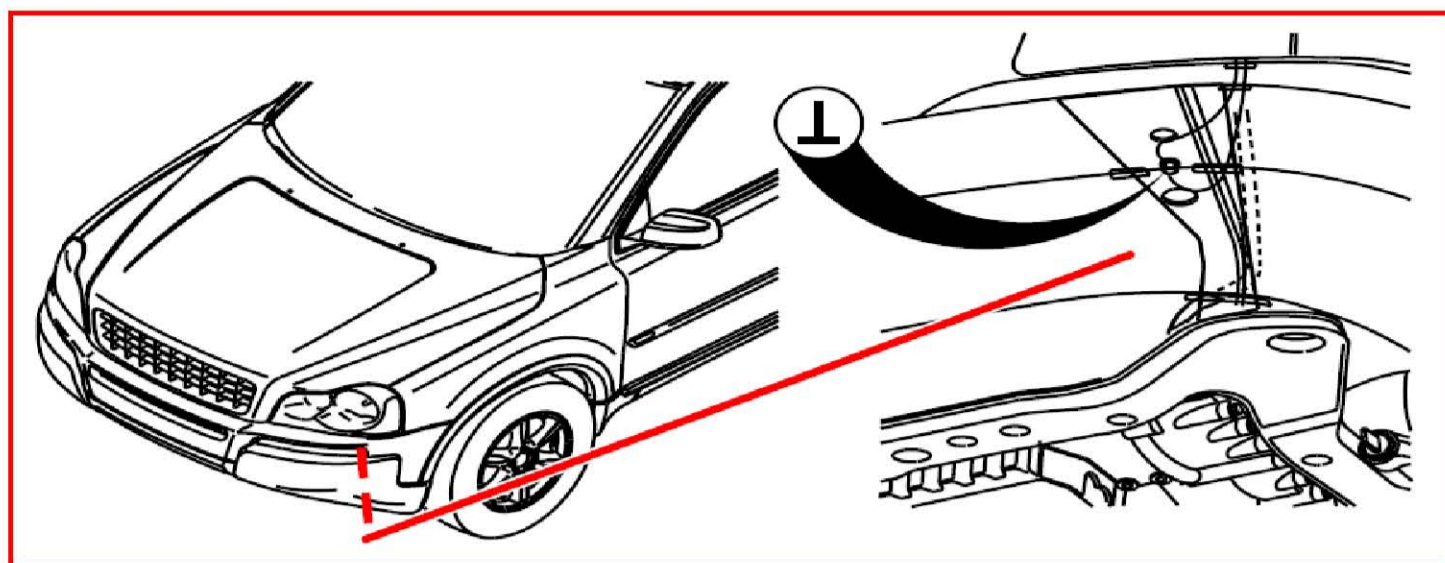
### 31/102 前樑接地 XC90

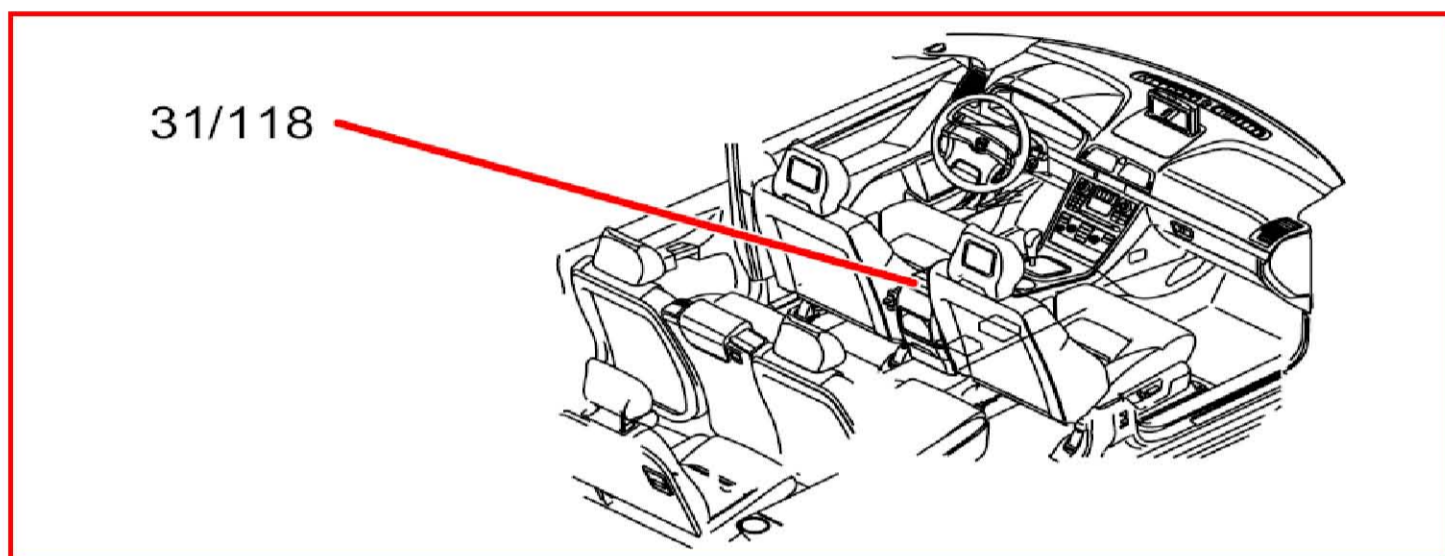
### 31/118 前部座椅之間扶手下接地

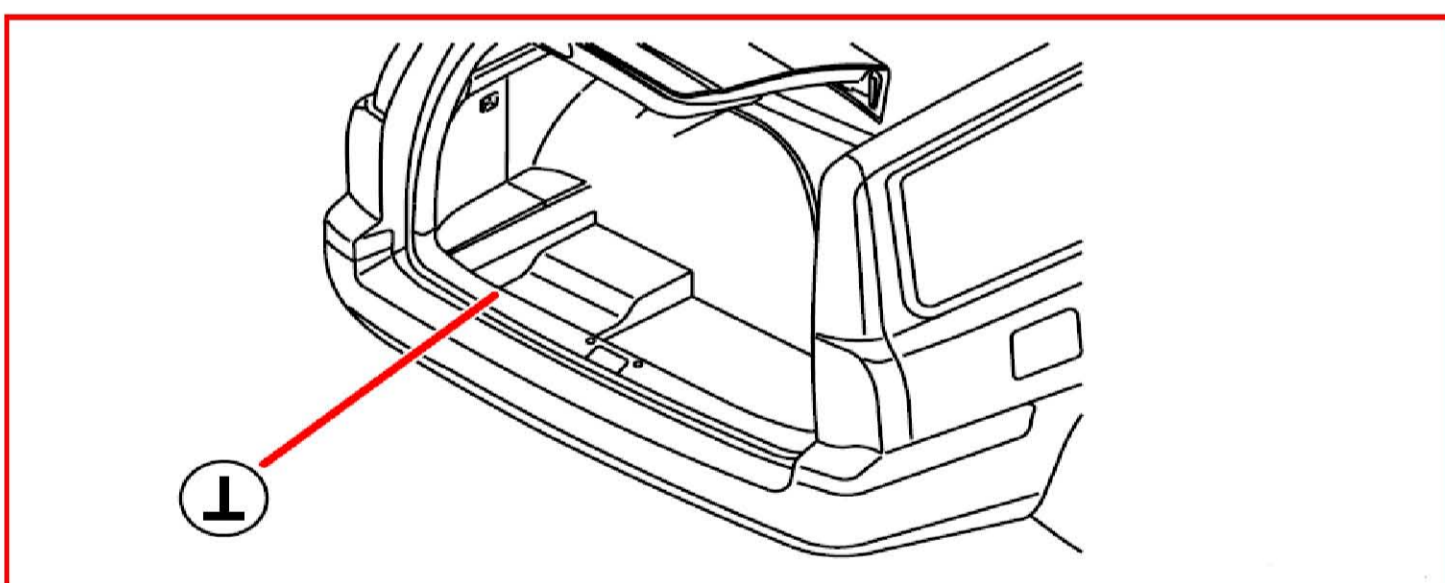
### 31/120 行李箱接地 V70

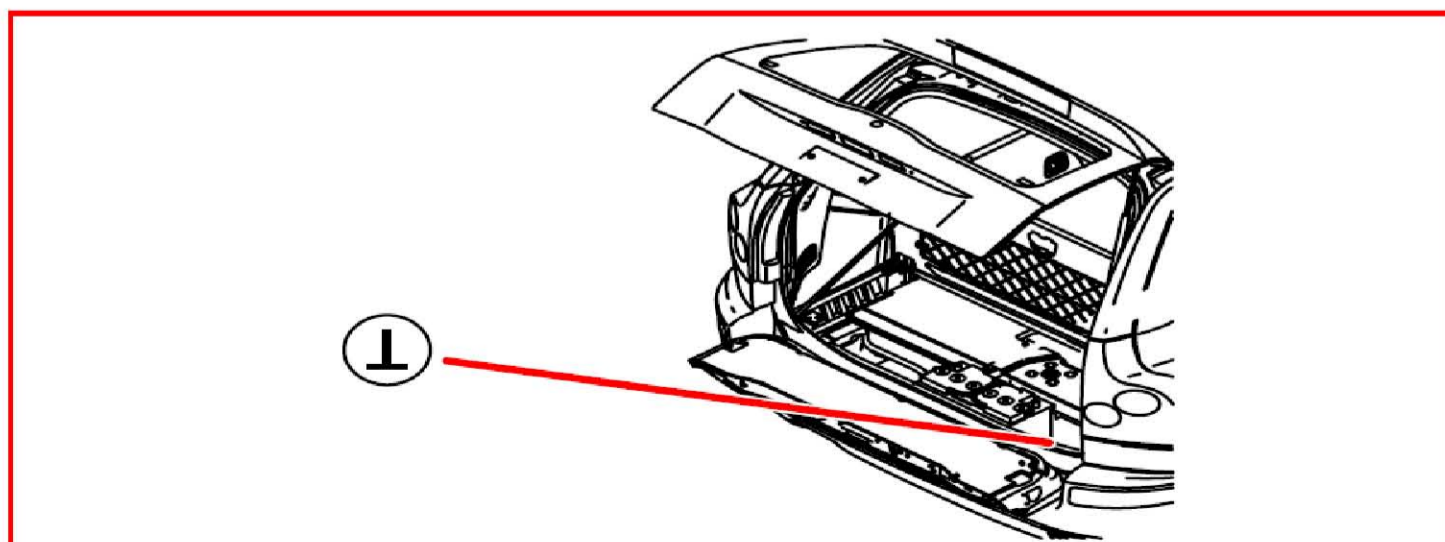
### 31/120 行李箱接地 XC90
