## BMW 528 Sunroof Normalization

Function description: BMW 528, FZD (sunroof function center) with the DTC “030215 SHD: No Normalization” present. The function "sunroof normalization" needs to be executed.

Supported product: Launch PRO or PAD series comprehensive diagnostic equipment

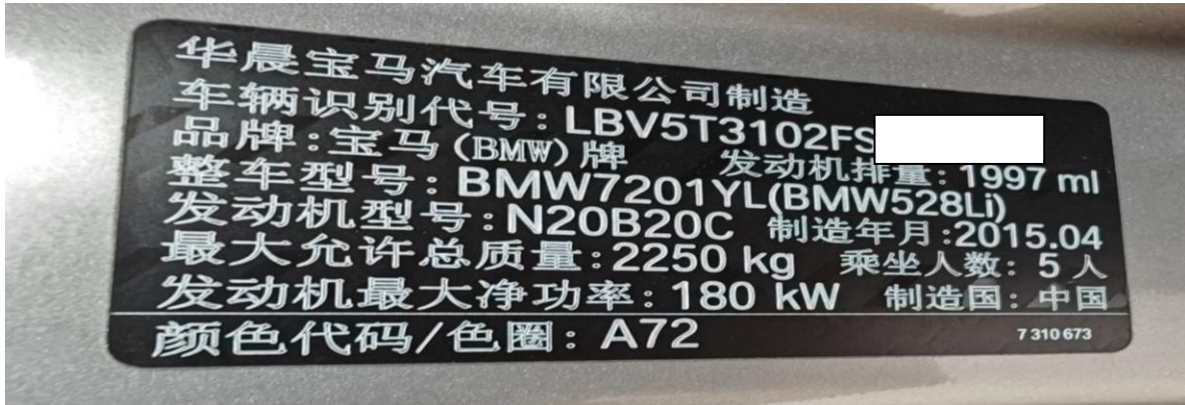
Tested model: 2015 BMW 528, VIN: LBV5T3102FS\*\*\*\*\* (as shown in the following figure)

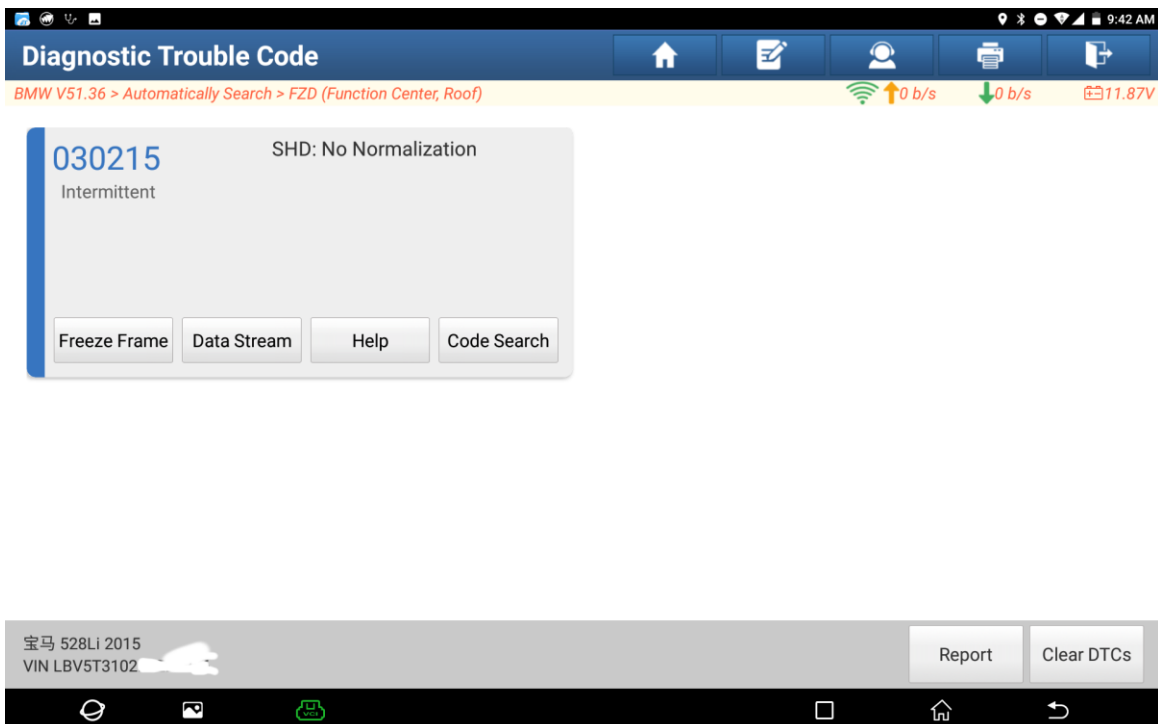
Figure 1

1. FZD (sunroof function center) with the DTC “030215 SHD: No Normalization” present (as shown in the following figure)

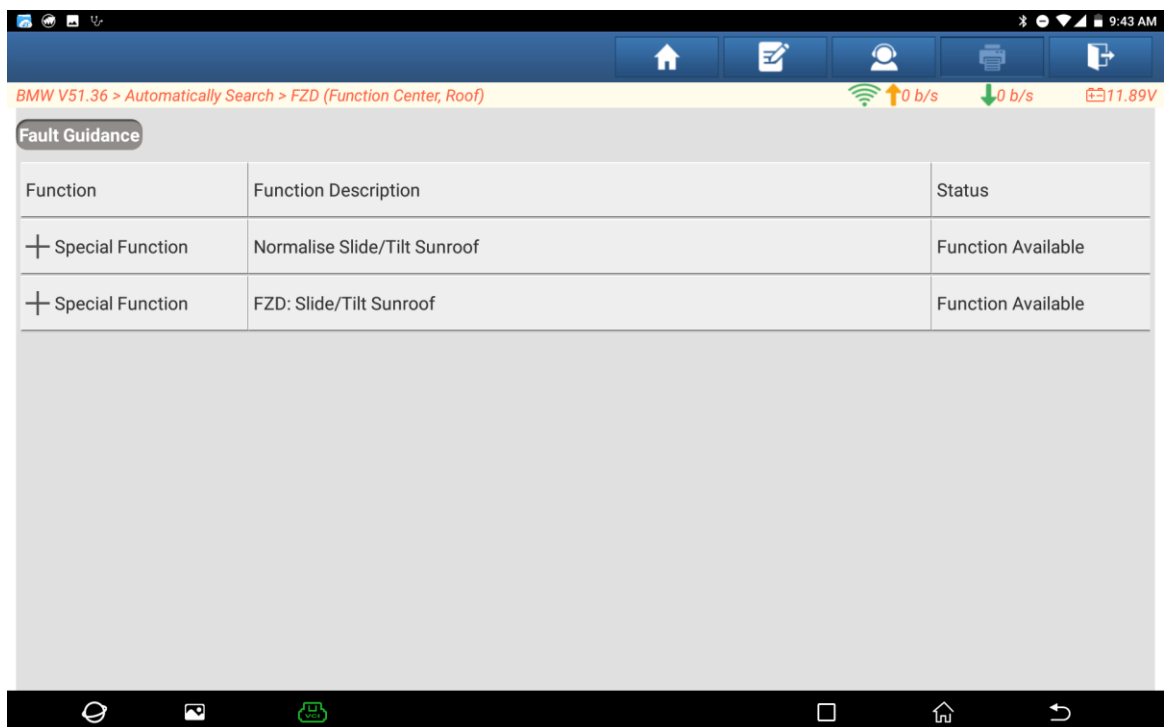
Figure 3

3. Choose **【Normalise Slide/Tilt Sunroof】** , as shown in the following figure.

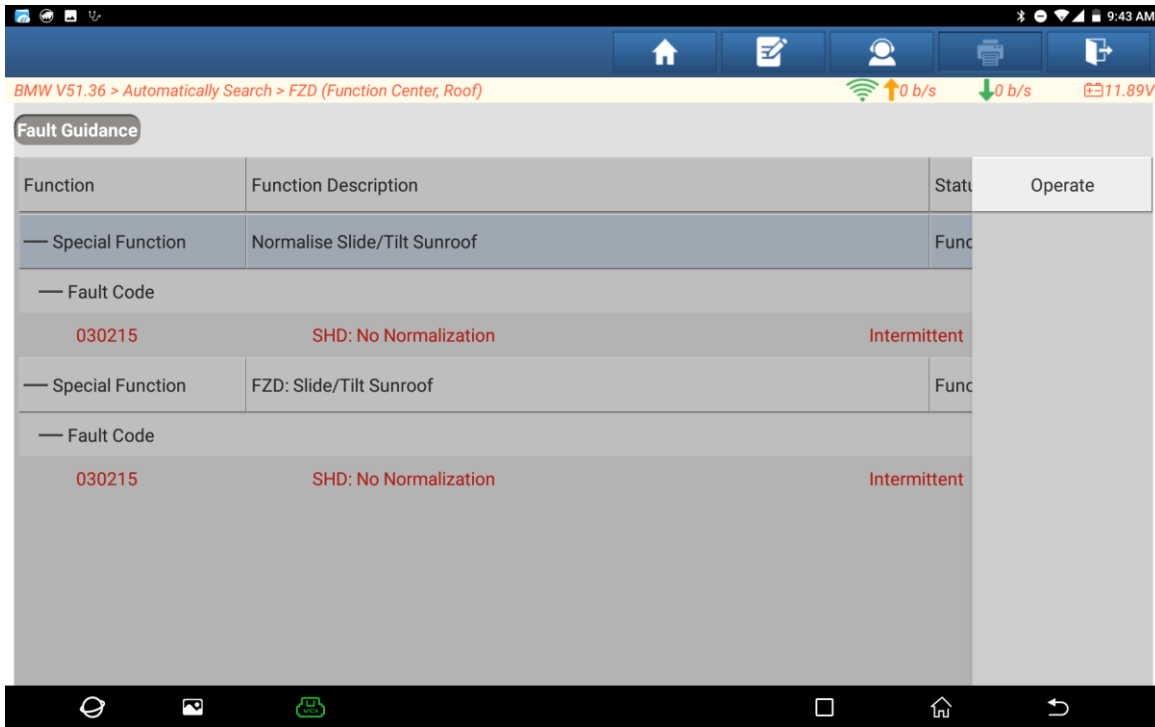
Figure 4

4. Click the "Operate" button in the upper right corner, as shown in the following figure.

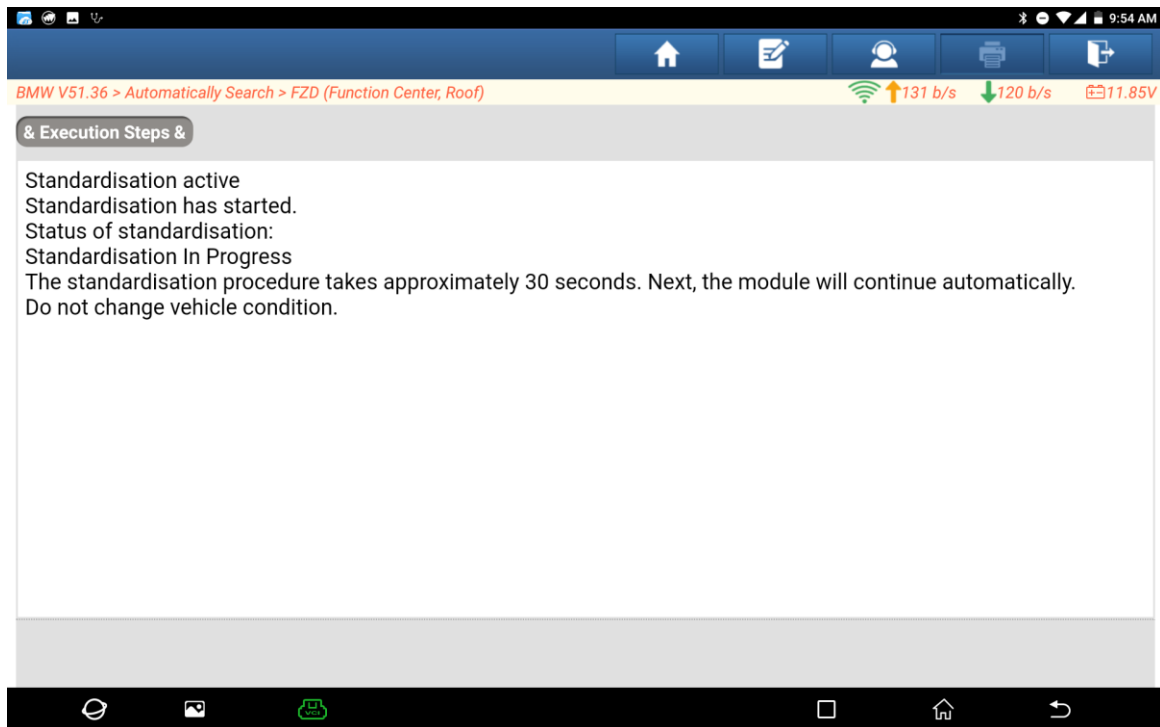
Figure 6

6. Normalization setting in process, as shown in the following figure.

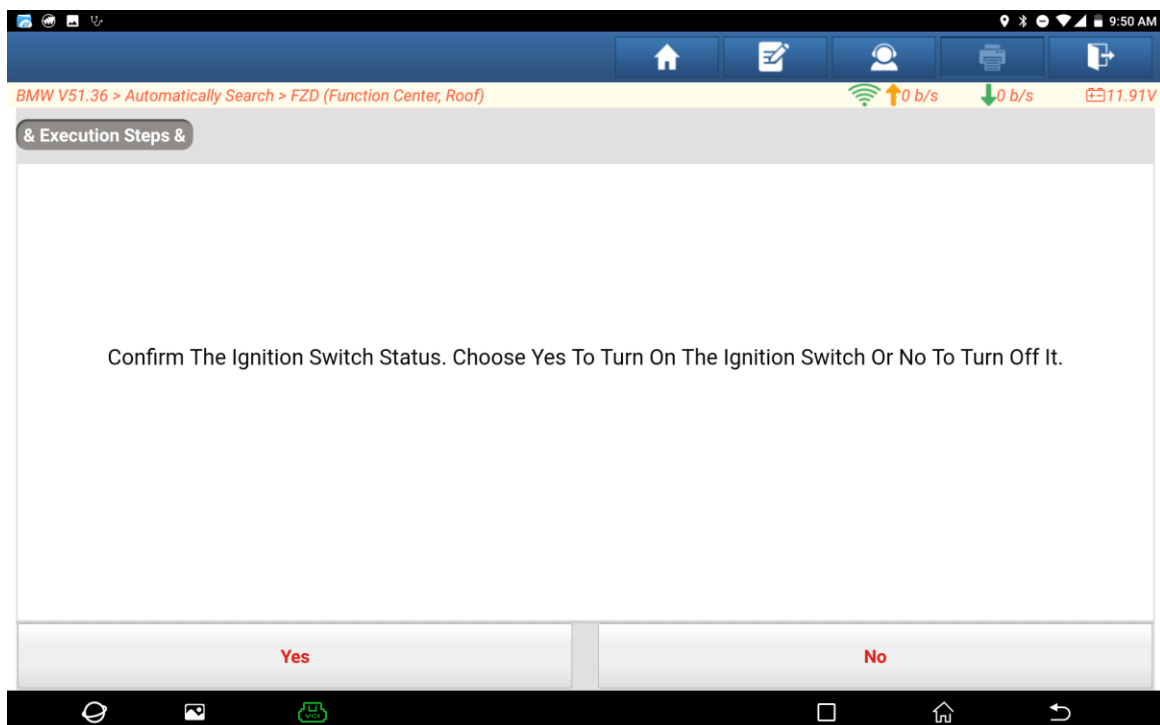
Figure 7

7. The ignition switch is on at this time. Choose "Yes", as shown in the following figure.

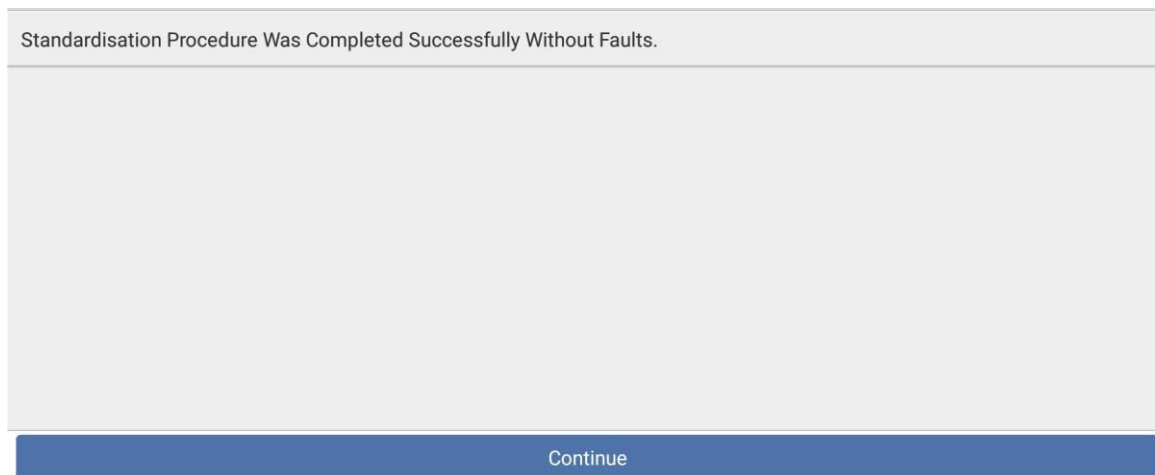
Figure 8

8. Normalization setting succeeds. Click “Continue”, as shown in the following figure.

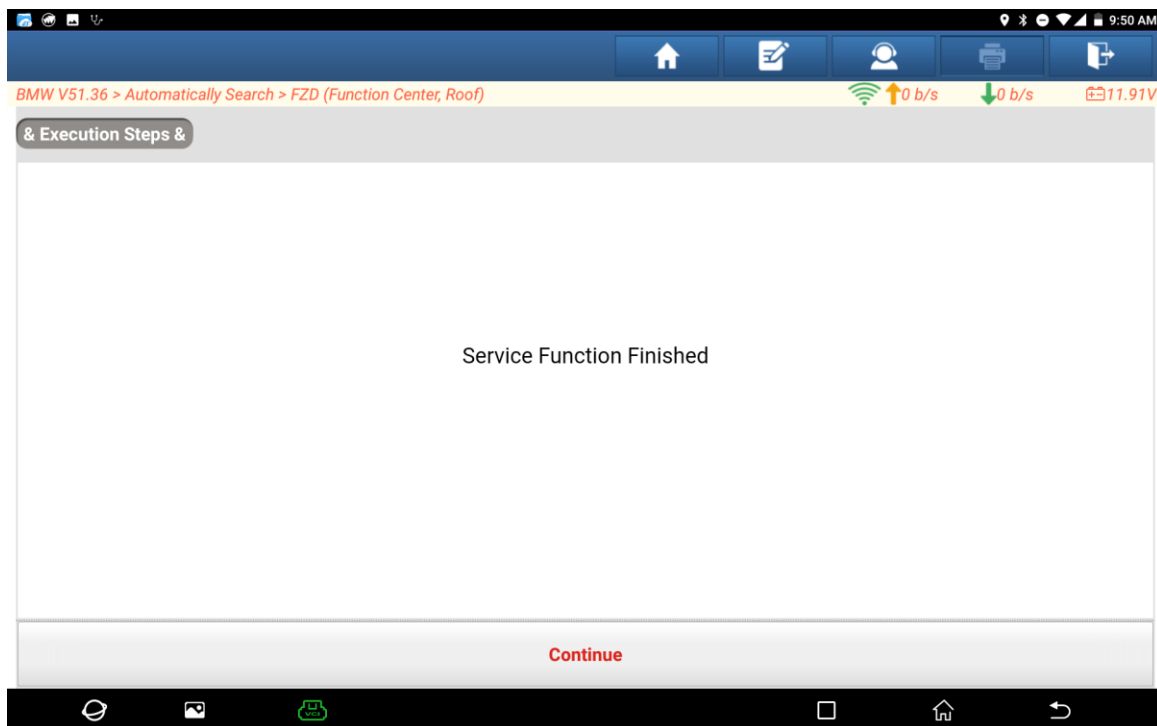
Figure 9

9. The service function is finished. Click “Continue”, as shown in the following figure.
