E65 Bodyshell

Introduction

The E65/E66 comes in 8 body variants. There are the following different variants for the models:

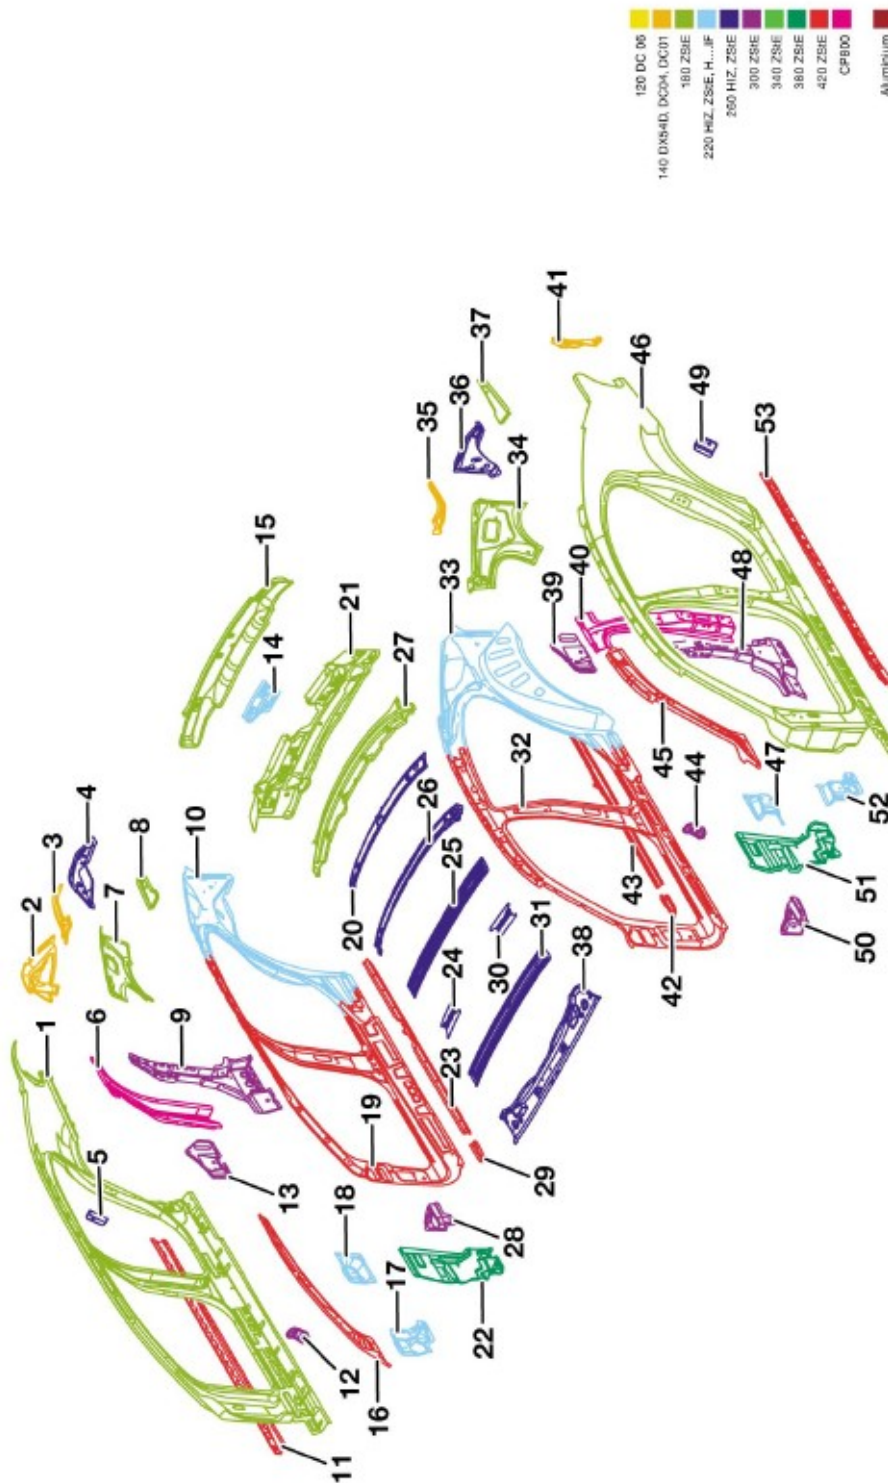
Fig. 10: Exploded view, side carcass

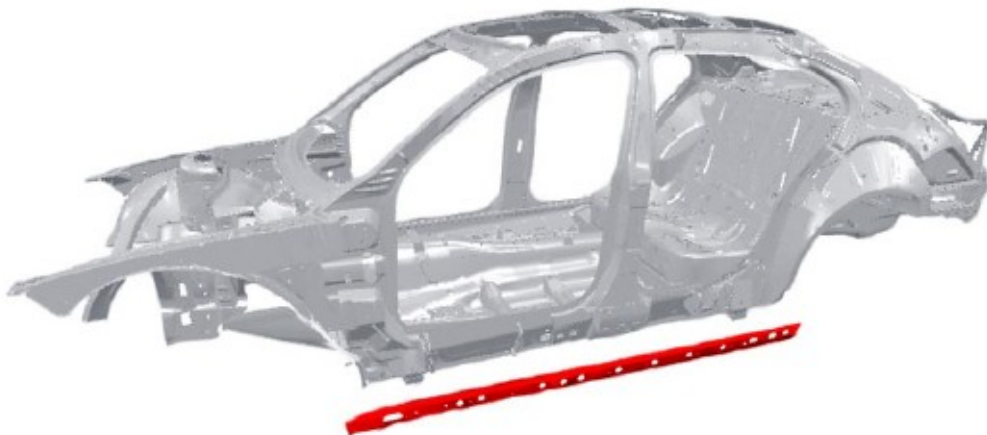
KT-8700

The profile section is reinforced at both sills by an additional reinforcement profile section (side-frame attachment), which also serves to accommodate the sill trim. This profile section offers additional safety in the event of both frontal and side impacts.

Fig. 11: Reinforcement profile section
