Seat Motor Calibration for 2013 Porsche Cayenne

Product Model	Date	Number
X-431 Pro series	20160310	——

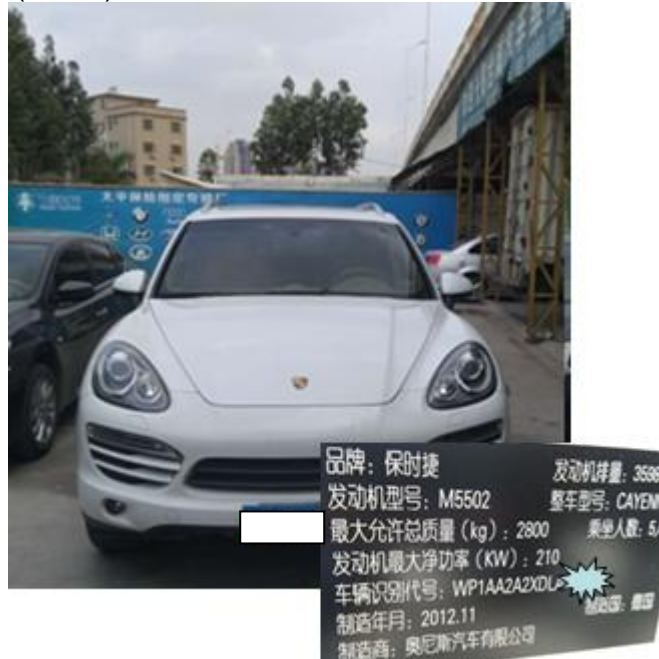
Picture 1

- Porsche Cayenne (2011-), 2013MY, VIN=WP1AA2A2XDLA*****, see Picture 1.

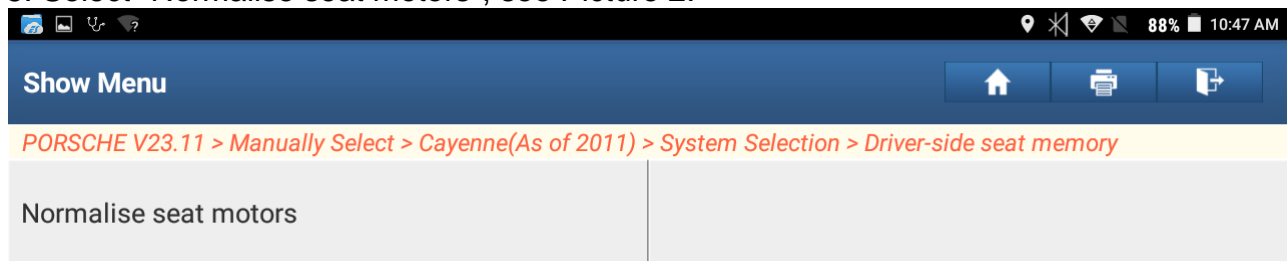
Picture 2

1. Select Porsche Version V21.40 or above.
2. Manually select Cayenne (as of 2011).
3. Select system selection.
4. Select driver seat memory.
5. Select "Normalise seat motors", see Picture 2.

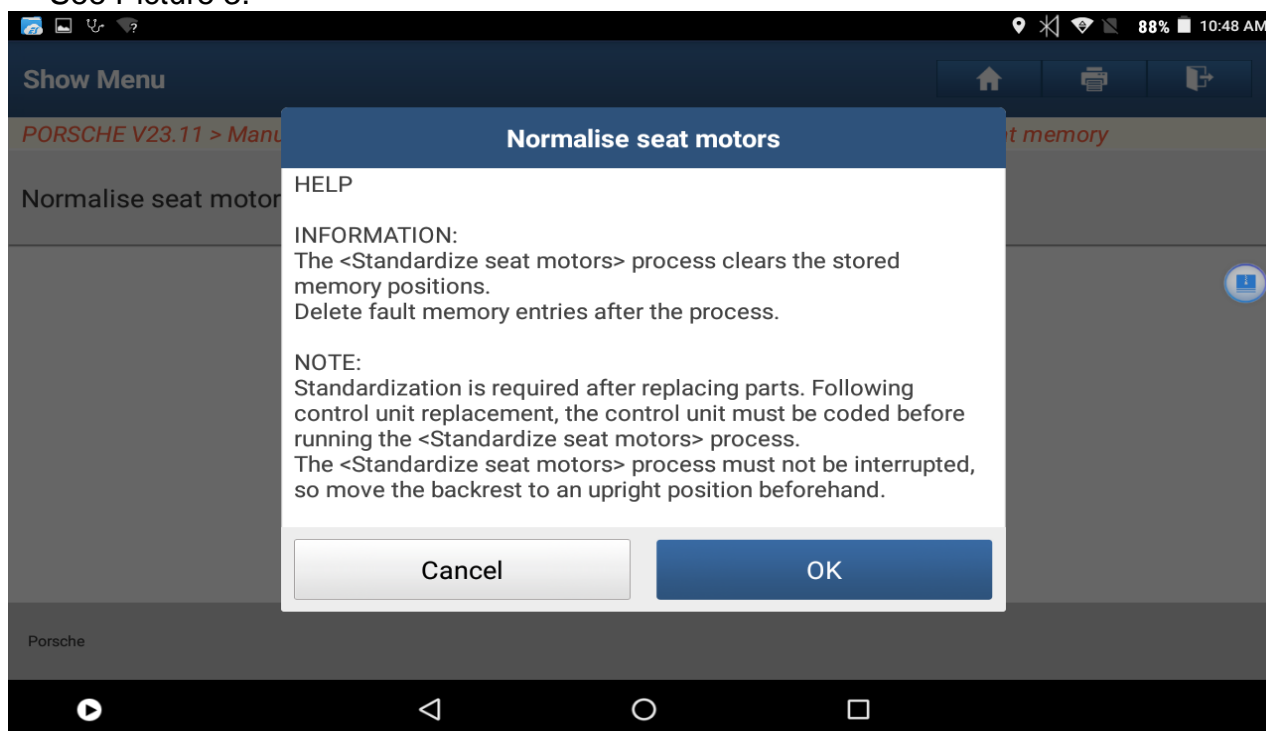
Picture 3

6. After selection, it prompts operation help information. Standardization is required after replacement of parts. After replacement of control unit, the control unit must be coded before running the procedure of normalizing seat motors. This standardization process must not be interrupted. Please move the backrest to an upright position beforehand. See Picture 3.

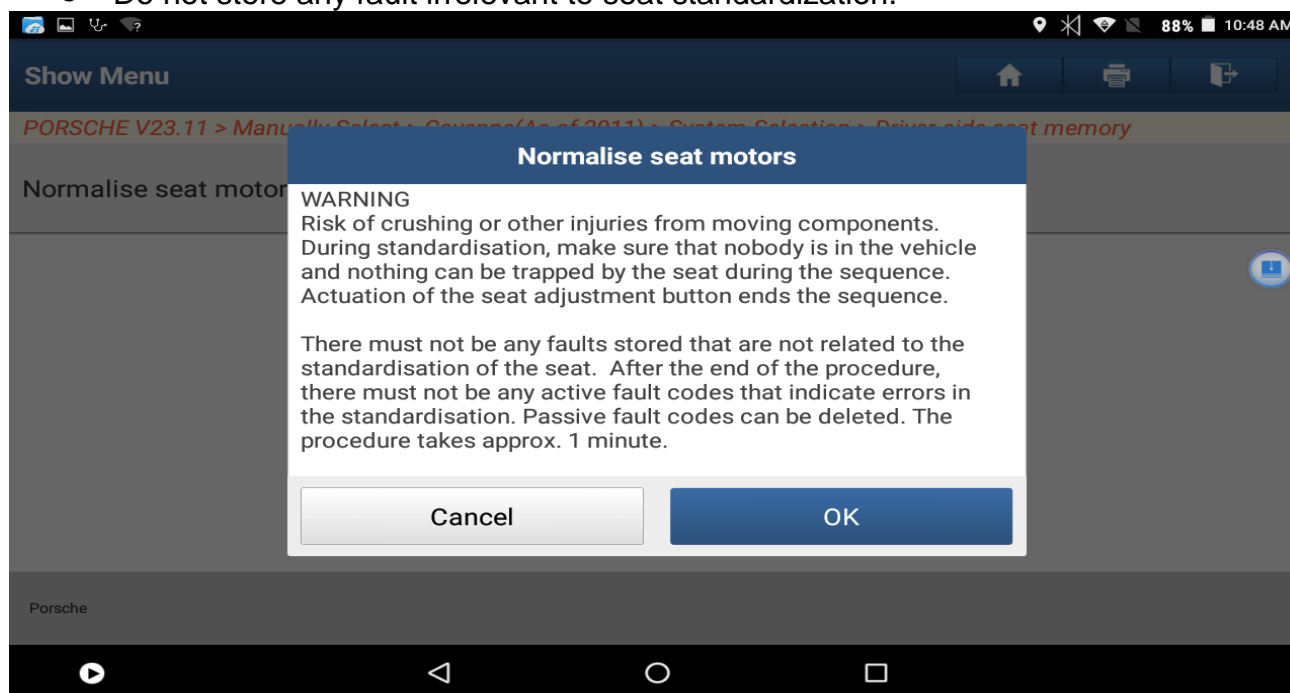
Picture 4

7. After clicking "OK", it displays warning information for the next step, see Picture 4.
- Parts movement may cause extrusion or other personal injuries. During the standardization, ensure no person in the car and when carrying out this function, no person or object will get stuck.
 - Do not store any fault irrelevant to seat standardization.

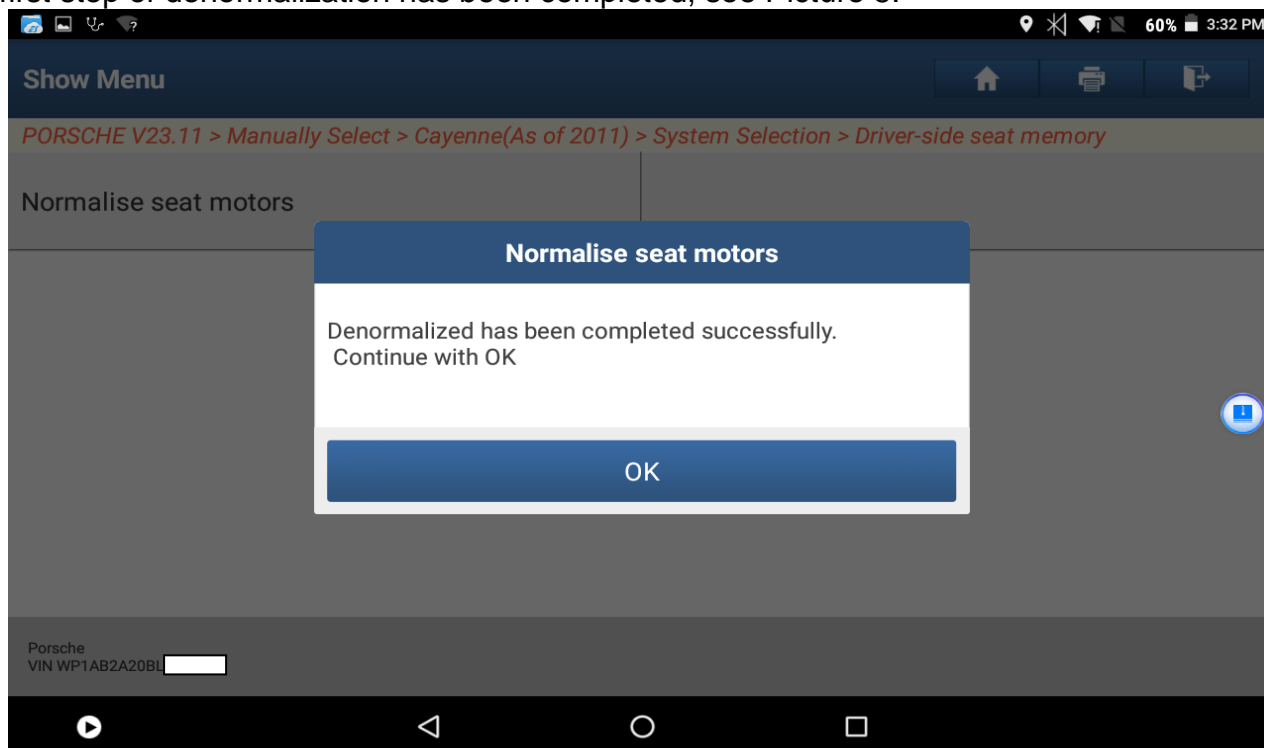
Picture 5

8. After clicking OK, the procedure will start automatically and it takes about 1 minute. The first step of denormalization has been completed, see Picture 5.

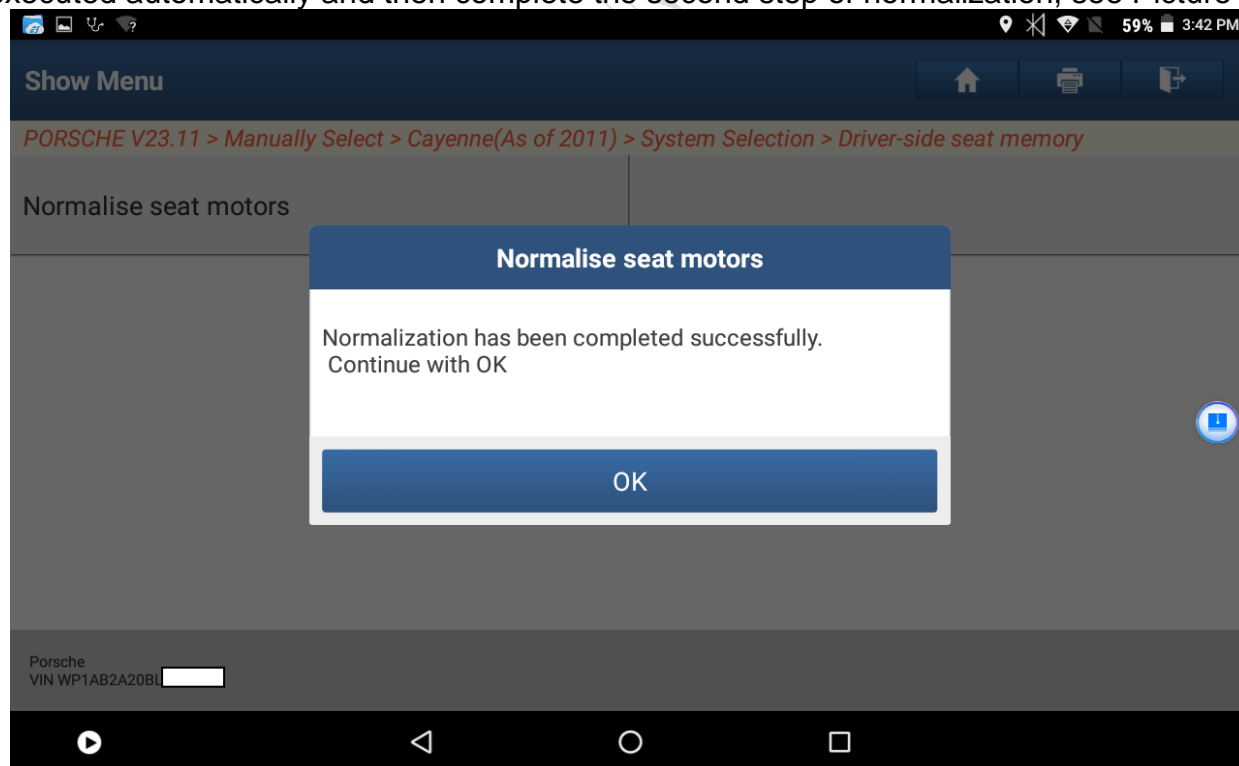
Picture 6

9. After successful completion of denormalization, click "OK". The procedure will be executed automatically and then complete the second step of normalization, see Picture 6.

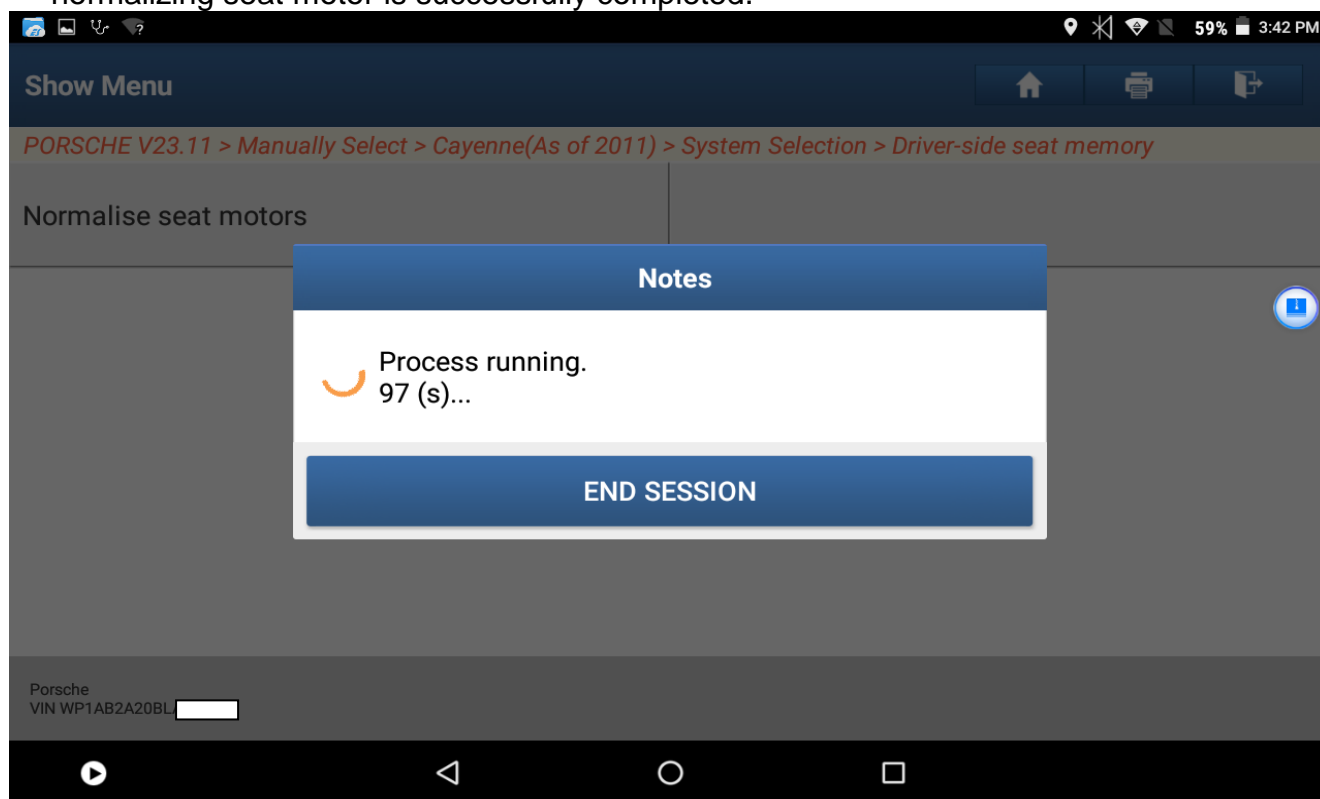
Picture 7

10. After successful completion of normalization, click OK. The procedure will be executed automatically. It takes about 100s, see Picture 7. After this, the entire process of normalizing seat motor is successfully completed.
