## 2018 Audi A4L Window Regulator Motor Basic Settings

2018 Audi A4L

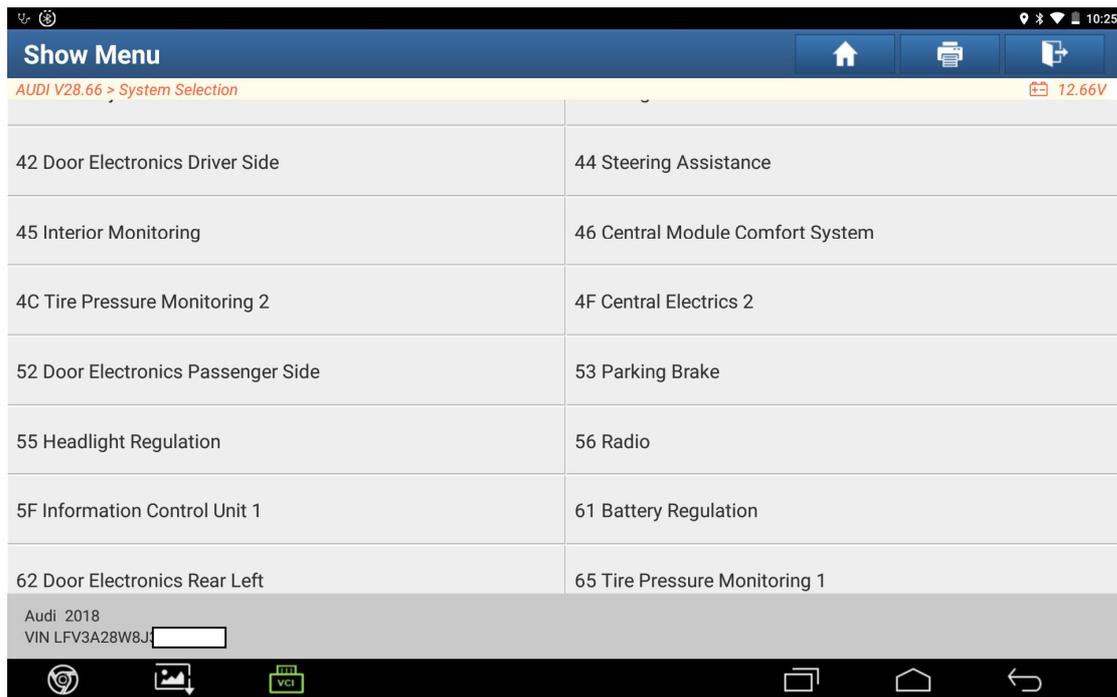
Figure 1

1) Select "42 door electronics driver side", as shown in Figure 1;

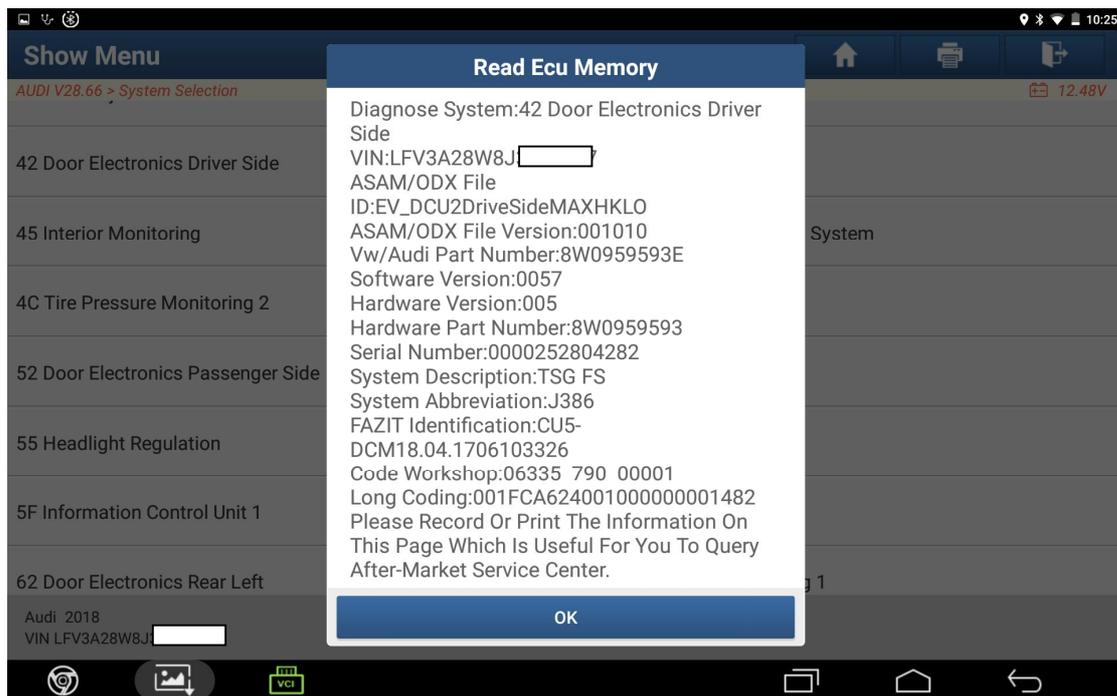
Figure 2

2) Click "OK" to continue, as shown in Figure 2;

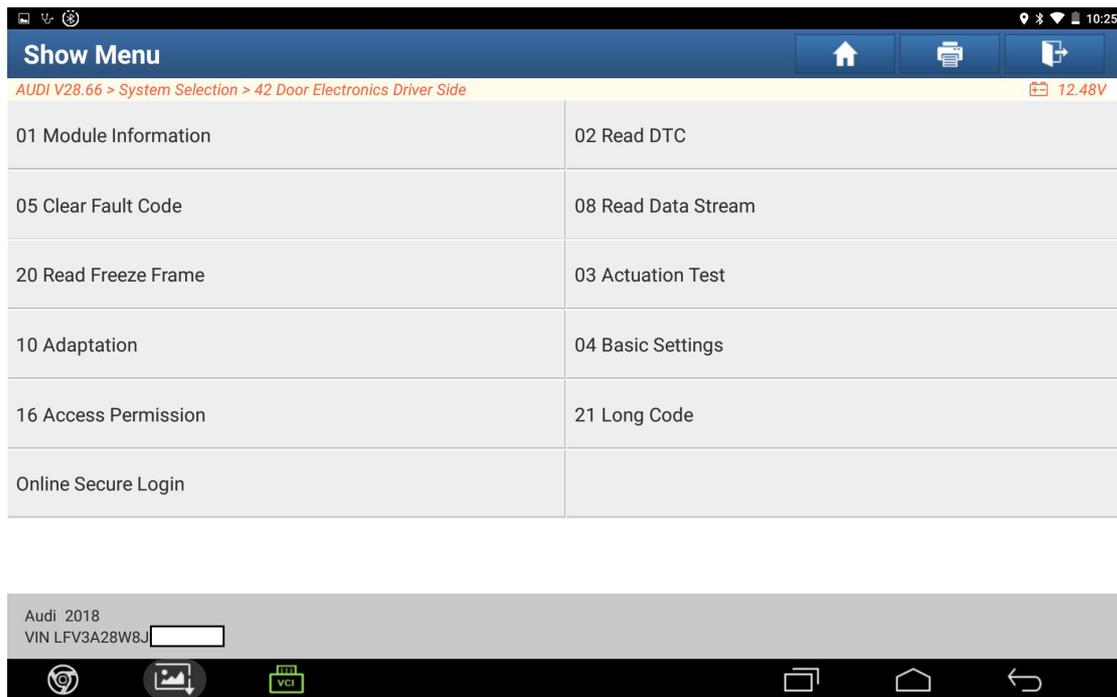
Figure 3

3) Select "02 read DTC", as shown in Figure 3;

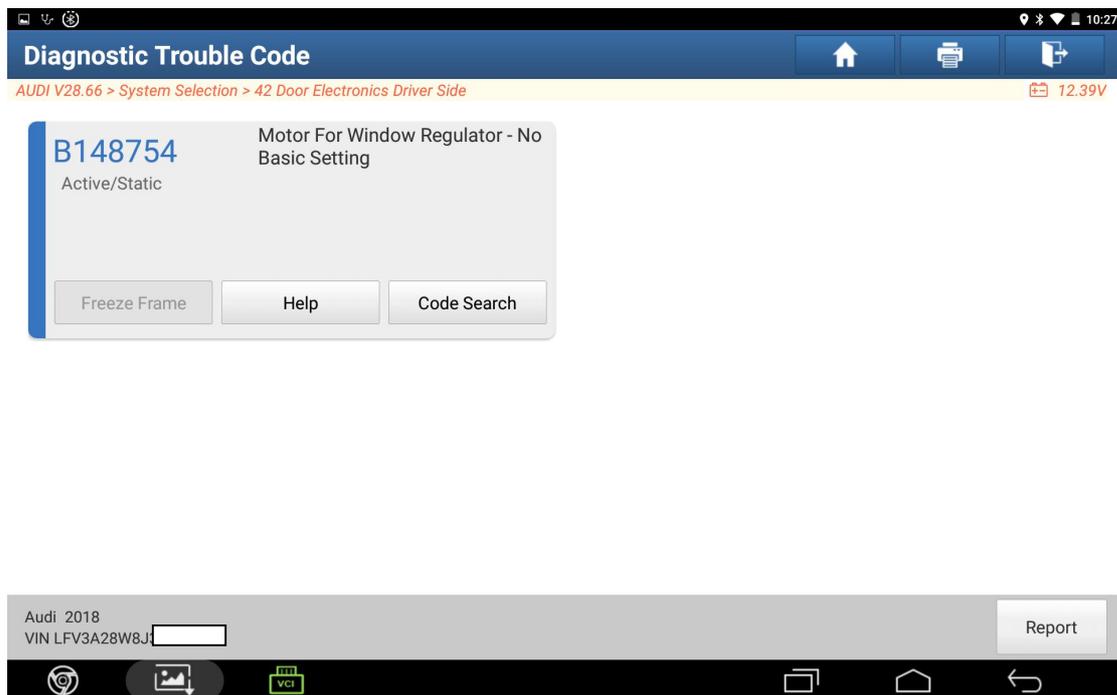
Figure 4

4) The fault code is: B148754 window lift motor-no basic settings, the fault code is active/static, and the fault code cannot be deleted, as shown in Figure 4;

Audi A4L window does not have one-key Regulator function, the fault code is: B148754 window Regulator motor-no basic settings. Use this function to make basic settings.

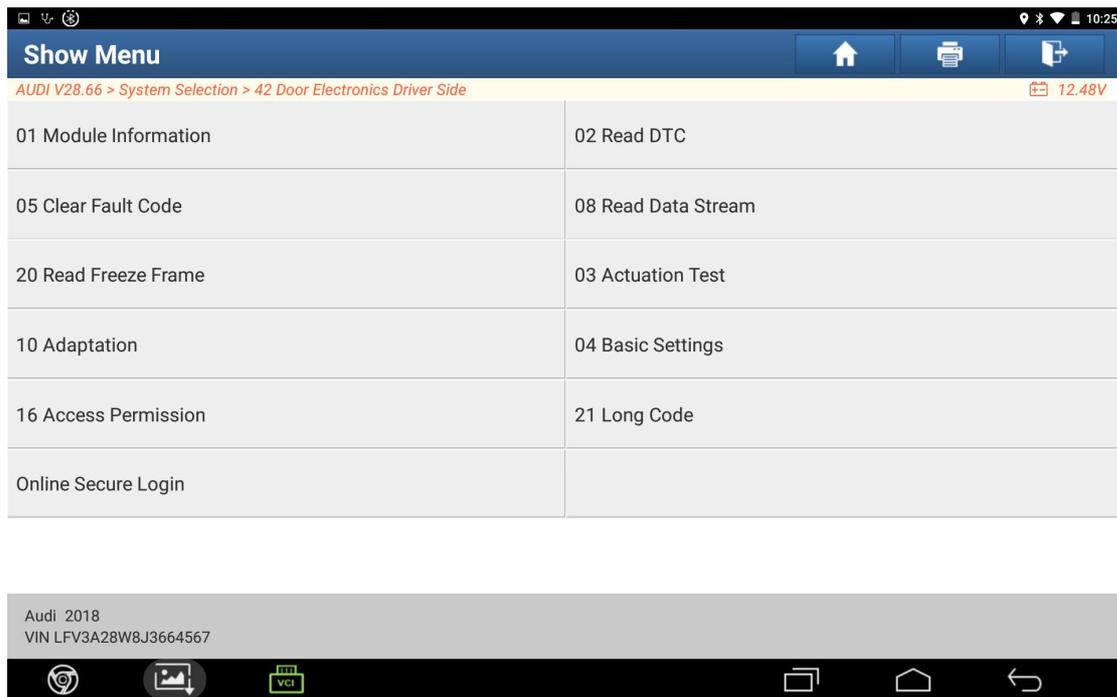
Figure 5

5) Select "04 Basic Settings", as shown in Figure 5;

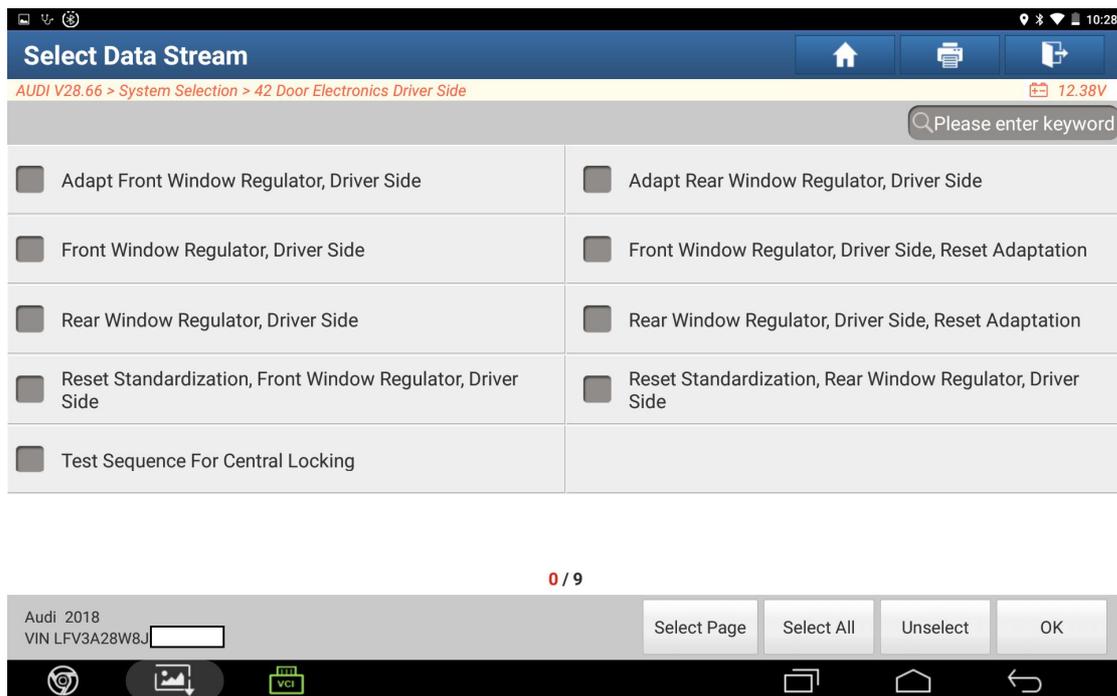
Figure 6

6) Function list, as shown in Figure 6;

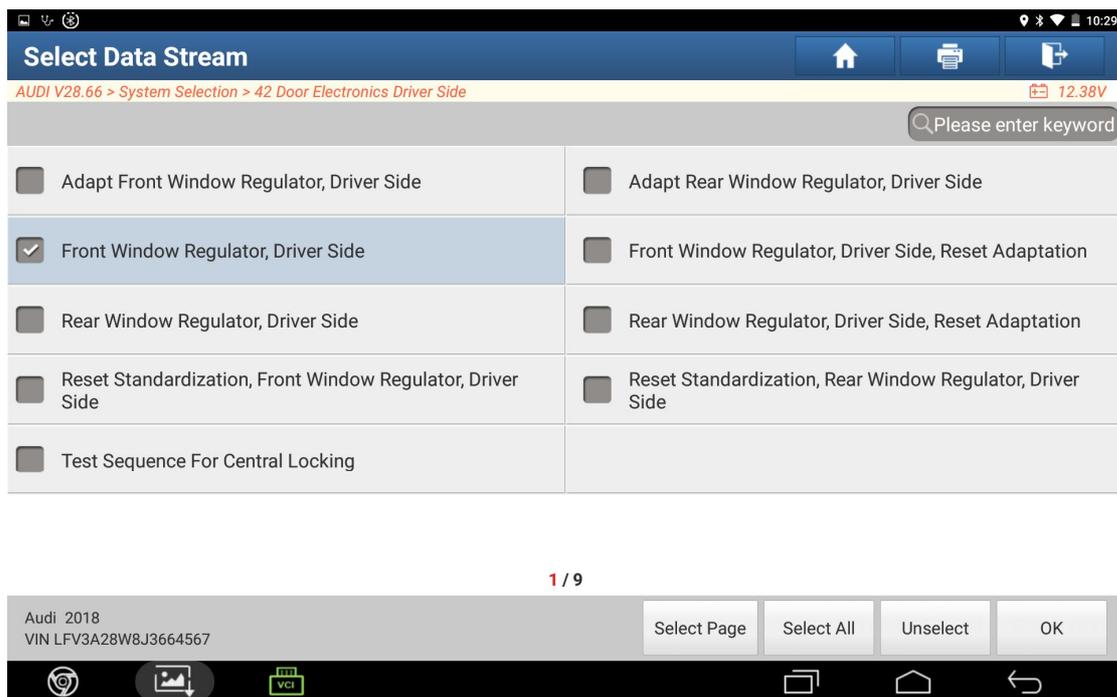
Figure 7

7) Select "Front Window Regulator, Driver Side", as shown in Figure 7;

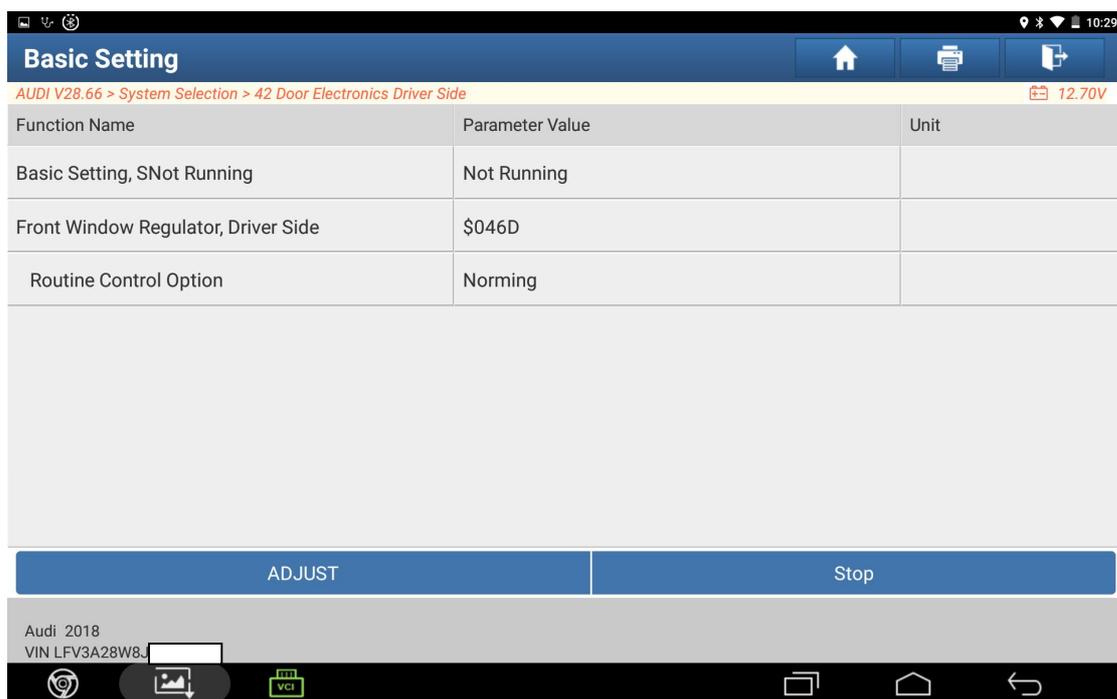
Figure 8

8) Click the "Adjust" button, as shown in Figure 8;

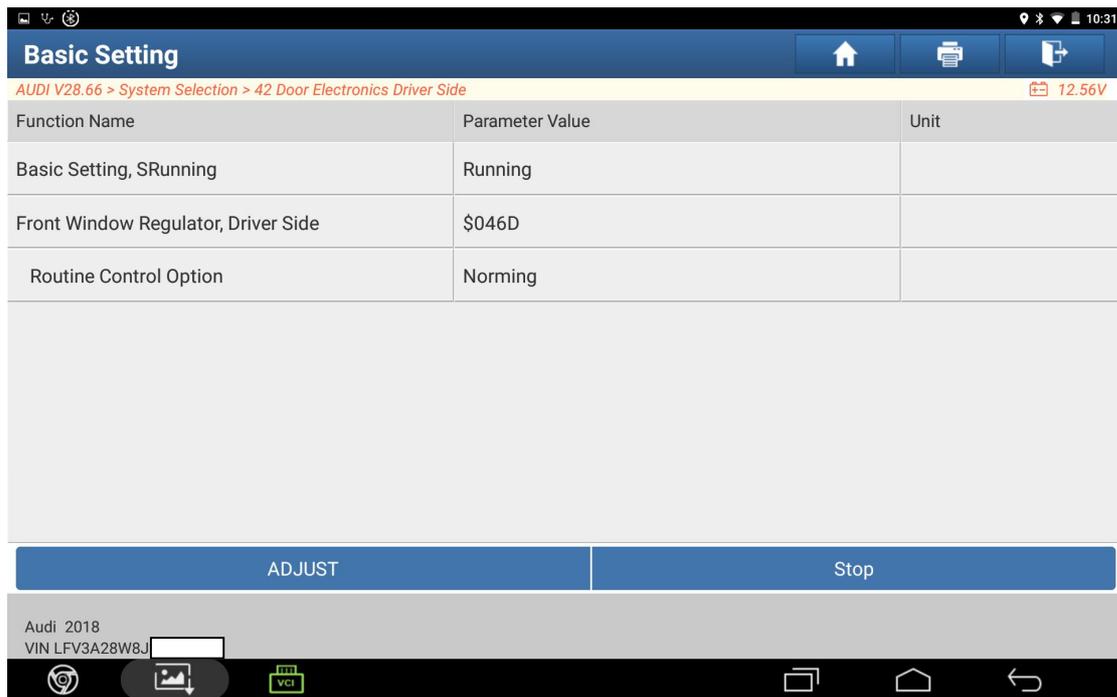
Figure 9

9) Basic settings are running, as shown in Figure 9;

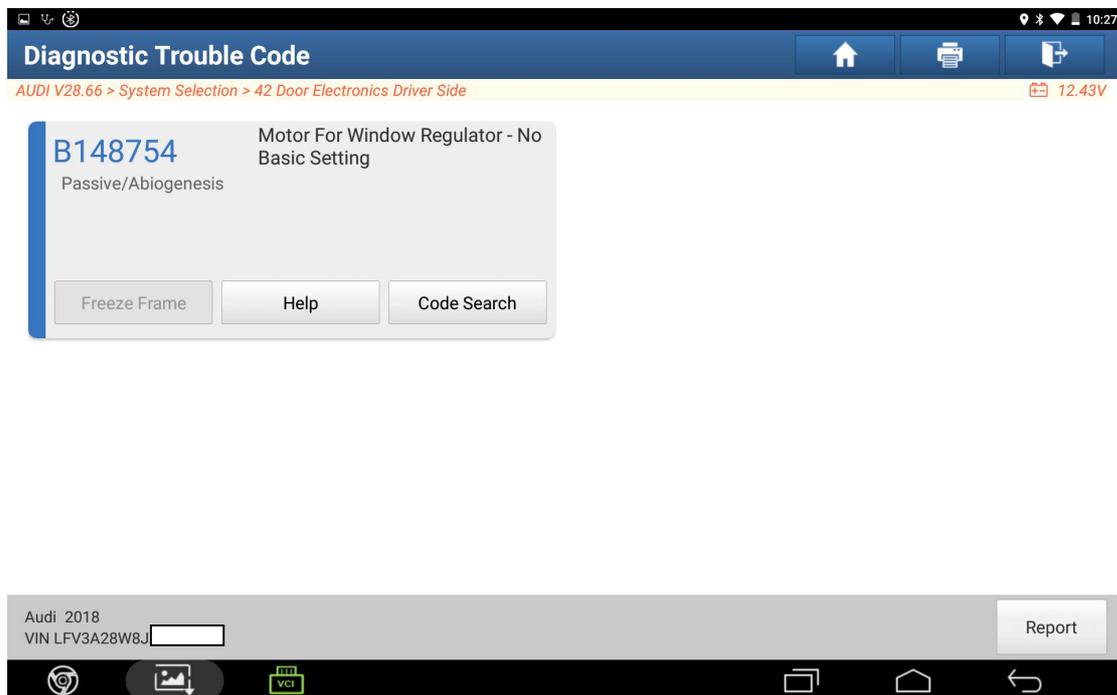
Figure 10

10) The fault code status changes from "active/static" to "passive/Abiogenesis", as shown in Figure 10;

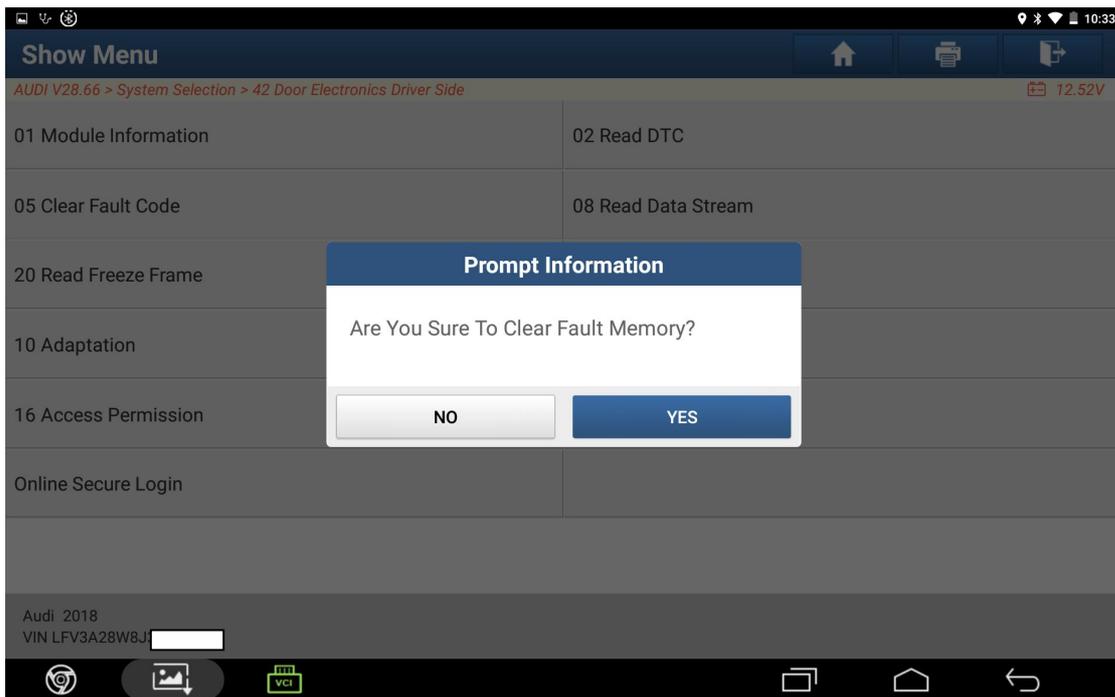
Figure 11

11) Click "Yes" to clear the fault code, as shown in Figure 11;

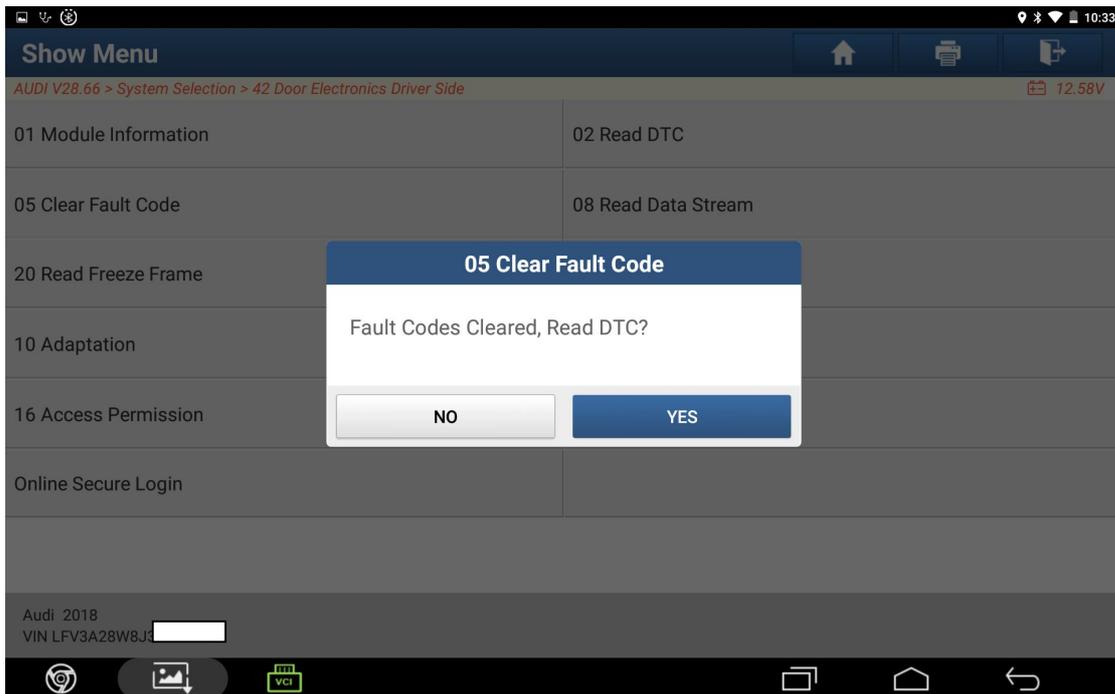
Figure 12

12) Click "Yes" to read DTC again, as shown in Figure 12;

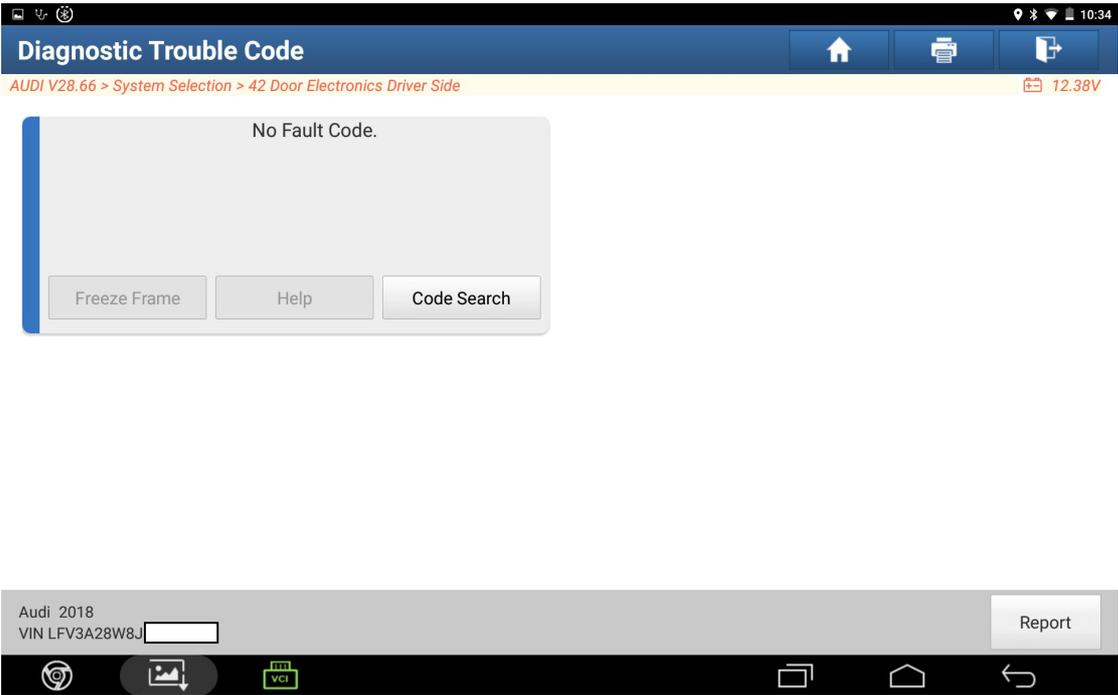
13) There is no fault code in the system, and the window has a key Regulator function, as shown in Figure 13;
