## 2023 年丰田 BZ3 前车门左右两侧把手初始化学习

2023 年丰田 BZ3 车辆 VIN 码：LFMAS14U8P0\*\*\*\*\*

**功能作用：** 更换左右两侧前车门把手或者控制模块后，需使用该功能对门把手位置进行学习

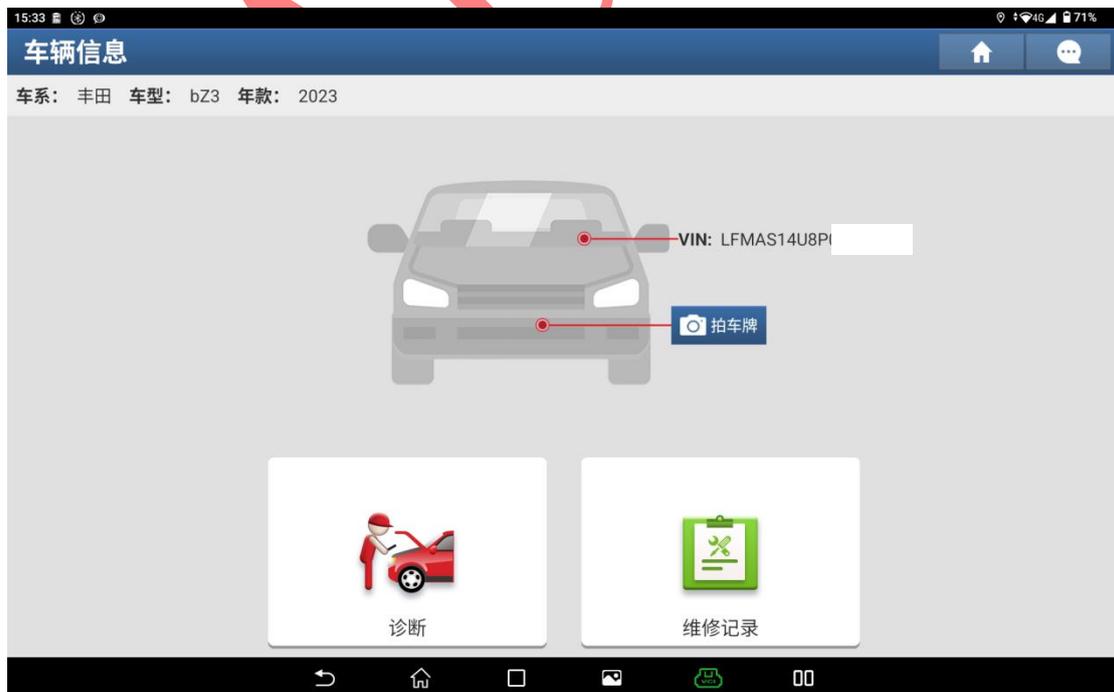
1. 选择【X431-PAD 5】设备，选择【智能诊断】识别车型，识别后选择【诊断】（如下图）；

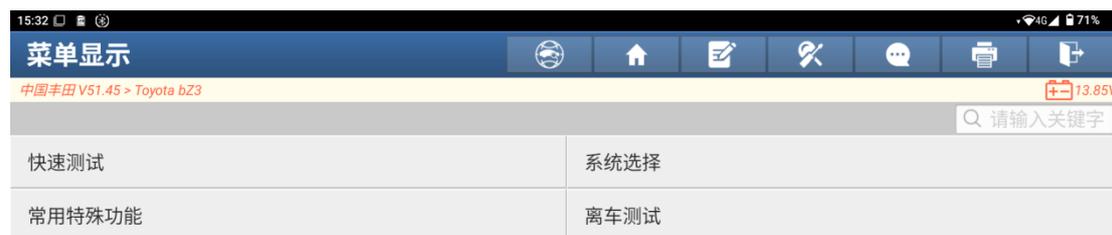
2. 选择“【快速测试】扫描系统（如下图）；

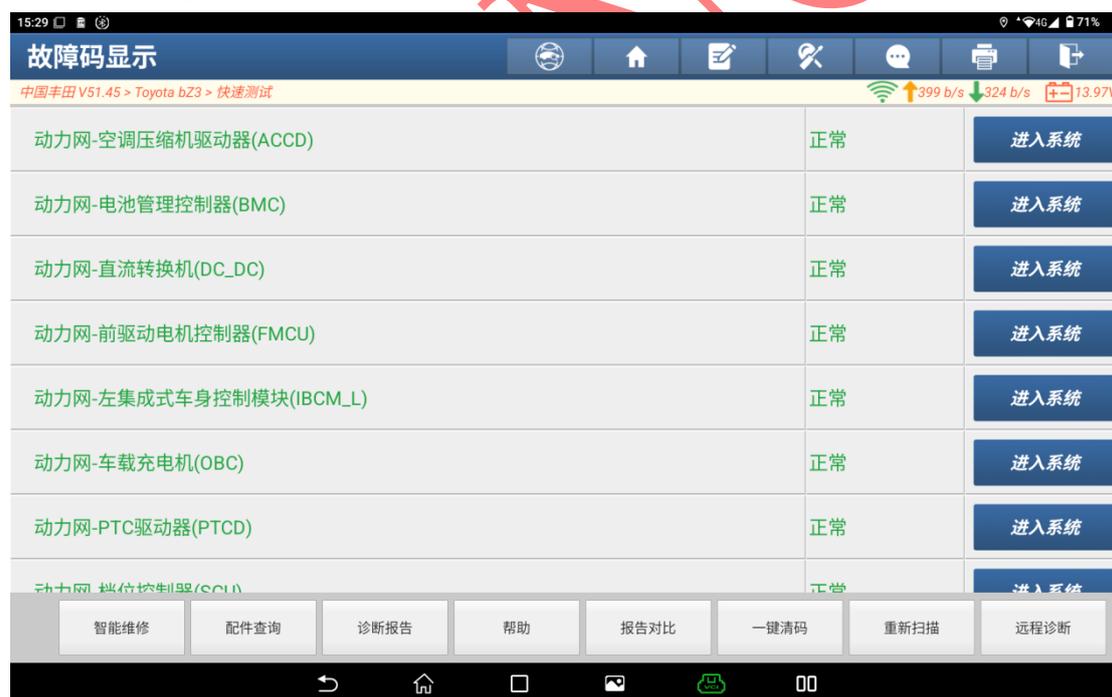
3. 选择【动力网-左集成式车身控制模块】（如下图）；

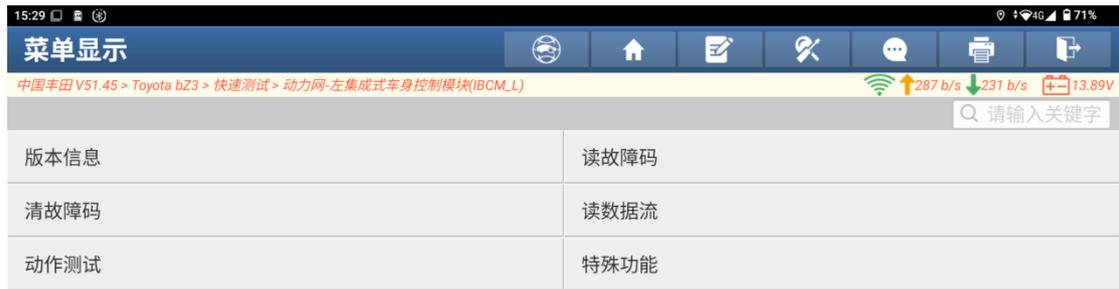
## 4. 选择【特殊功能】(如下图);

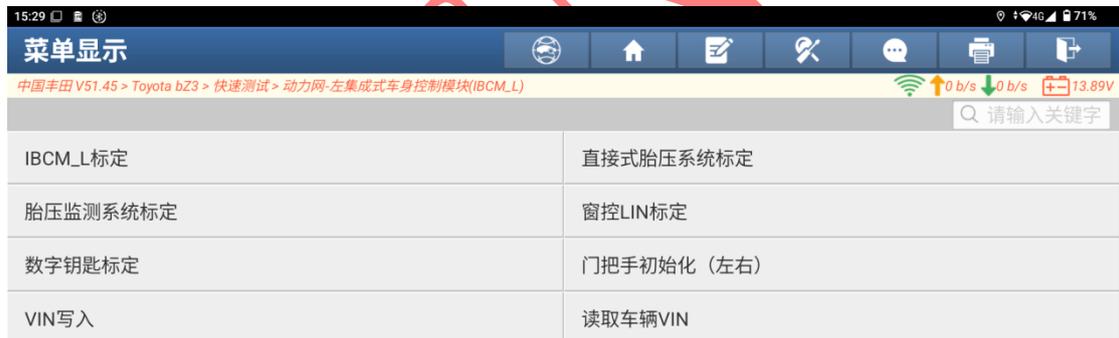
## 5. 选择【门把手初始化 (左右)】(如下图);

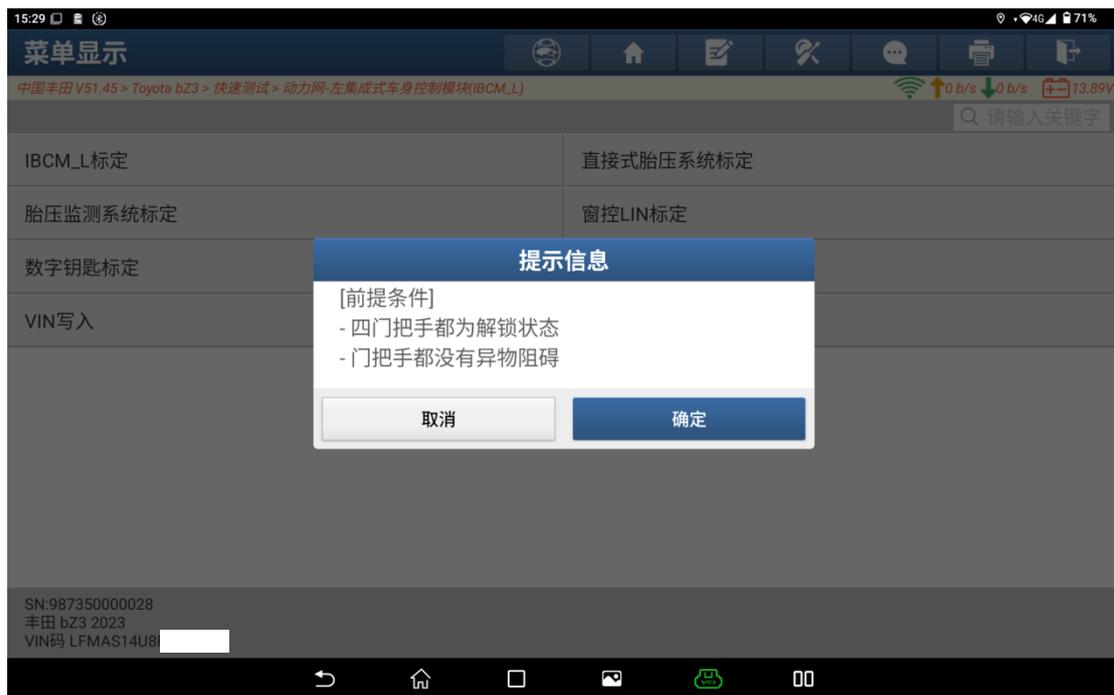
6. 阅读提示，满足条件后点“确定”（如下图）：

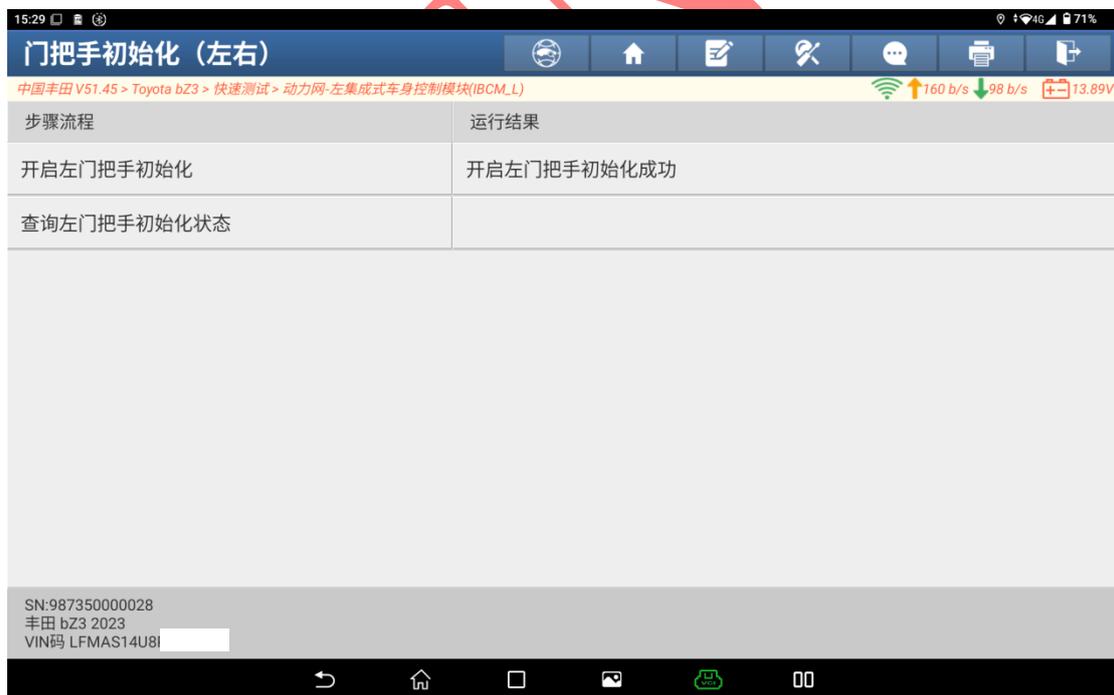
7. 提示【正在开启门把手初始化】（如下图）：

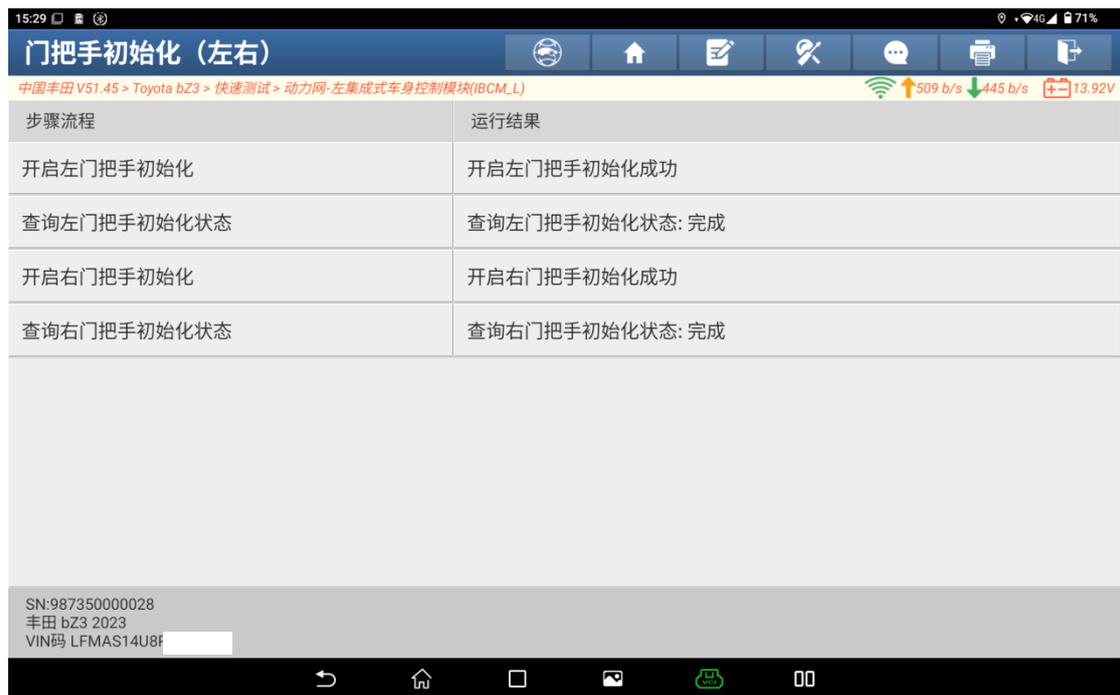
8. 提示【左右两侧前车门把手学习完成】，点“返回”菜单学习结束（如下图）。

The screenshot shows a diagnostic tool interface with a table of initialization results. The title bar reads '门把手初始化 (左右)'. The breadcrumb path is '中国丰田 V51.45 > Toyota bZ3 > 快速测试 > 动力网-左集成式车身控制模块(BCM\_L)'. The status bar shows network speed (509 b/s up, 445 b/s down) and battery voltage (13.92V). The table has two columns: '步骤流程' (Step Process) and '运行结果' (Run Result). The steps include opening and querying the status of both left and right door handles, all of which are marked as successful. At the bottom, vehicle information is displayed: SN: 987350000028, 丰田 bZ3 2023, and VIN: LFMAS14U8F [redacted].

步骤流程	运行结果
开启左门把手初始化	开启左门把手初始化成功
查询左门把手初始化状态	查询左门把手初始化状态: 完成
开启右门把手初始化	开启右门把手初始化成功
查询右门把手初始化状态	查询右门把手初始化状态: 完成
