Seat Motor Calibration for 2013 Porsche Cayenne

Product Model	Date	Number
X-431 Pro series	20160310	——

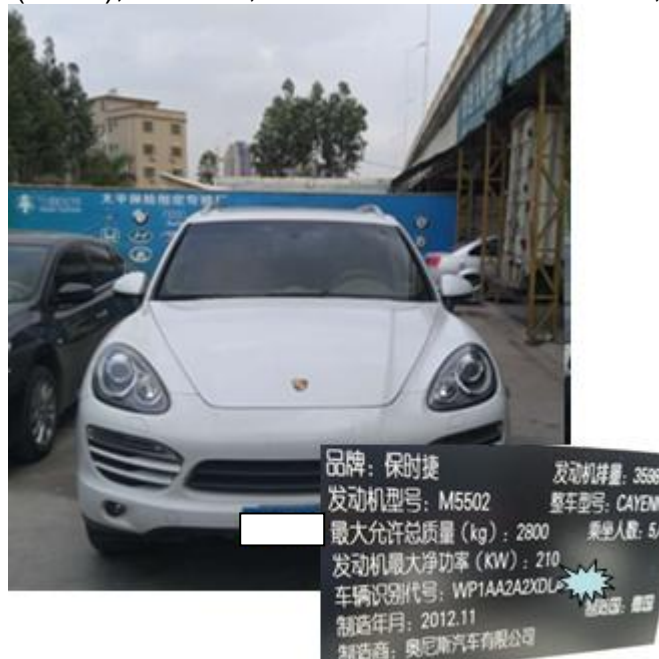
Picture 1

- Porsche Cayenne (2011-), 2013MY, VIN=WP1AA2A2XDLA****, see Picture 1.

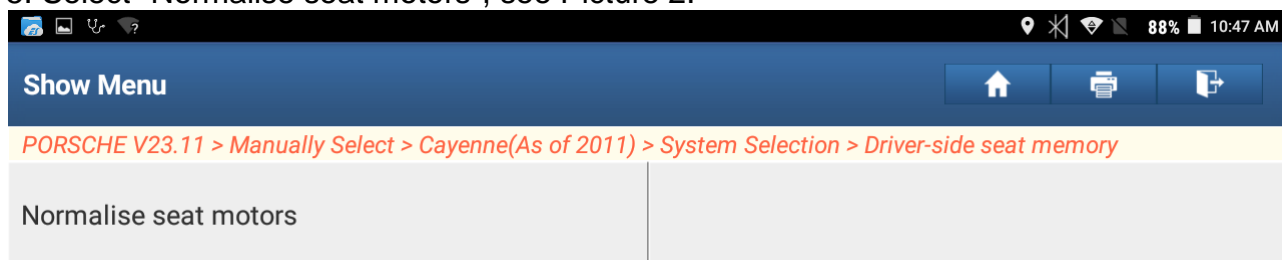
Picture 2

1. Select Porsche Version V21.40 or above.
2. Manually select Cayenne (as of 2011).
3. Select system selection.
4. Select driver seat memory.
5. Select "Normalise seat motors", see Picture 2.

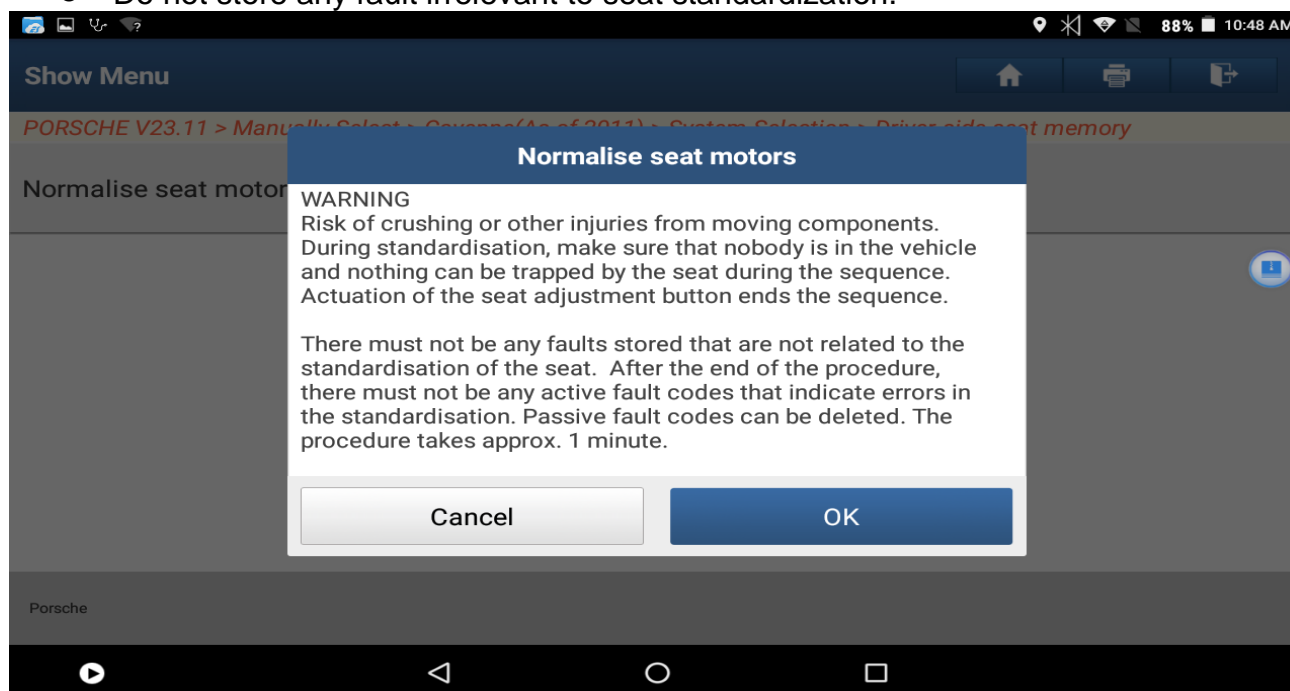
Picture 4

7. After clicking "OK", it displays warning information for the next step, see Picture 4.
- Parts movement may cause extrusion or other personal injuries. During the standardization, ensure no person in the car and when carrying out this function, no person or object will get stuck.
 - Do not store any fault irrelevant to seat standardization.
