Basic Settings of VW Magotan Longitudinal Acceleration Sensor

Function description: On VW Magotan 2009, the 53 parking brake has the DTC: 01279 longitudinal acceleration sensor without or incorrect basic settings/matching. The basic settings of the longitudinal acceleration sensor need to be performed.

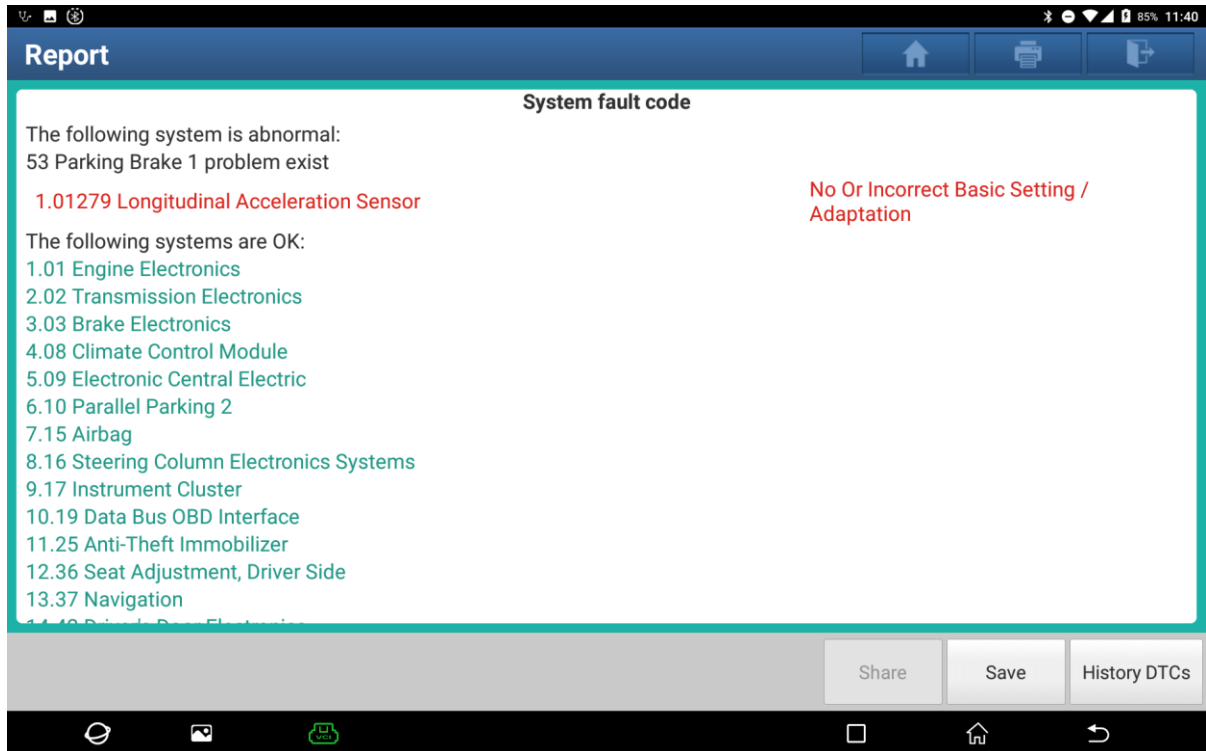
Figure 1

1. Save the fault report. The 53 parking brake has the DTC: 01279 longitudinal acceleration sensor without or incorrect basic settings/matching. (See the following figure.)

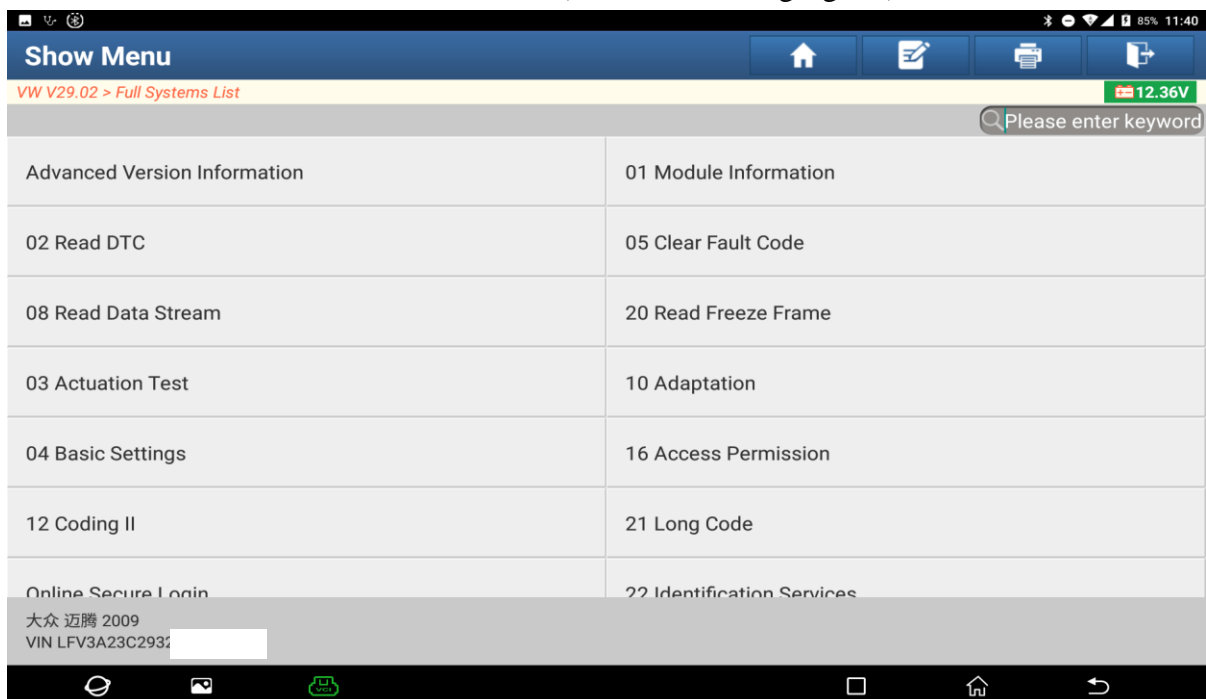
Figure 2

2. The 53 parking brake does not have the basic settings of the longitudinal acceleration sensor. Access "03 Brake Electronics". (See the following figure.)

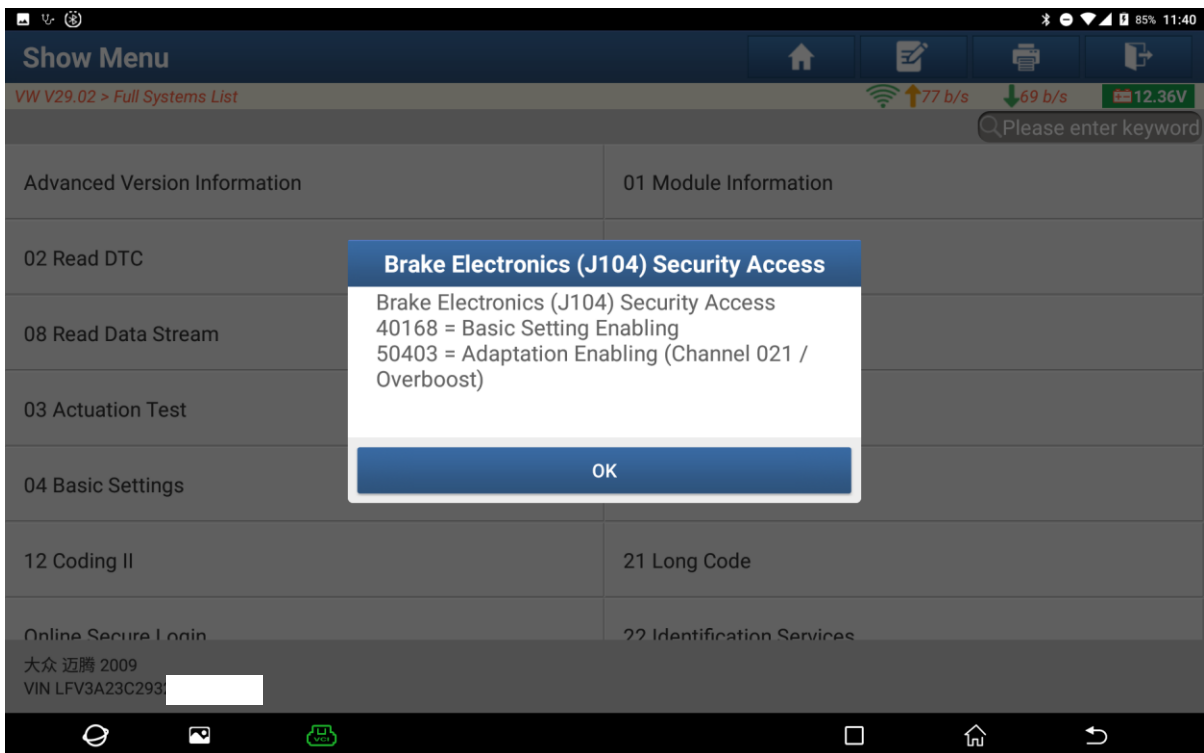
Figure 3

3. Choose [16 Access Permission]. 40168= basic setting enabling. Click OK. (See the following figure.)

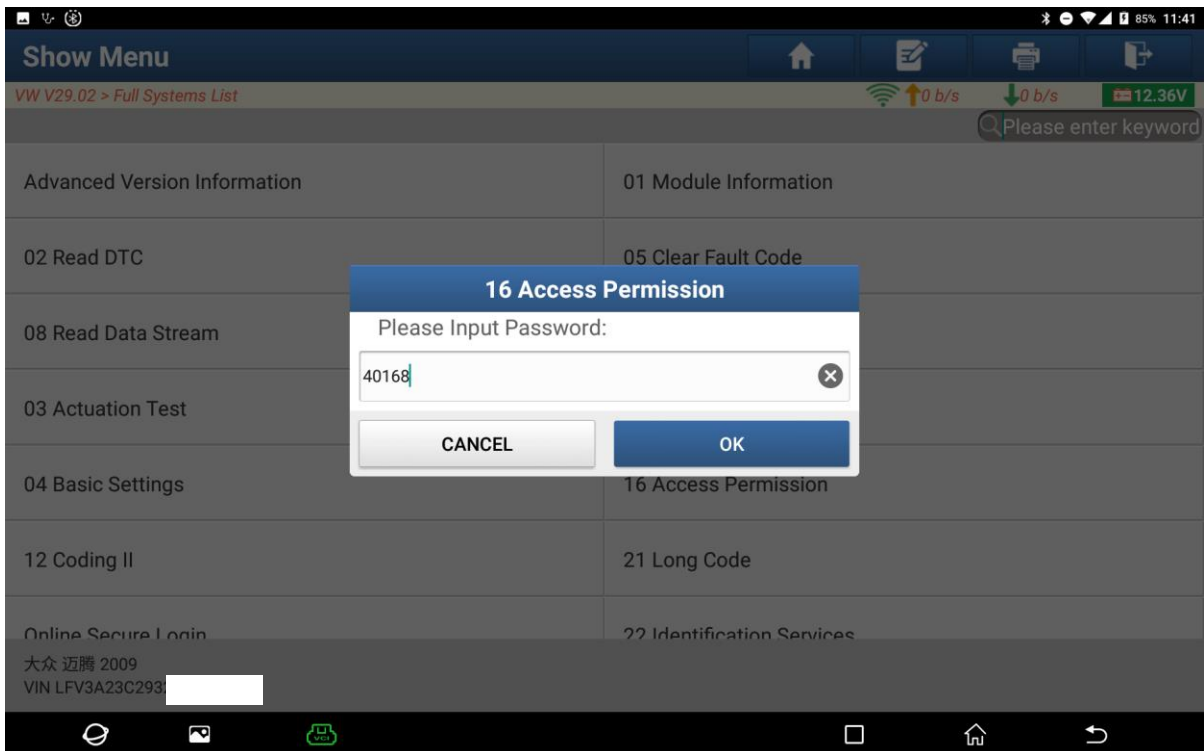
Figure 4

4. Input "40168". Click OK. (See the following figure.)

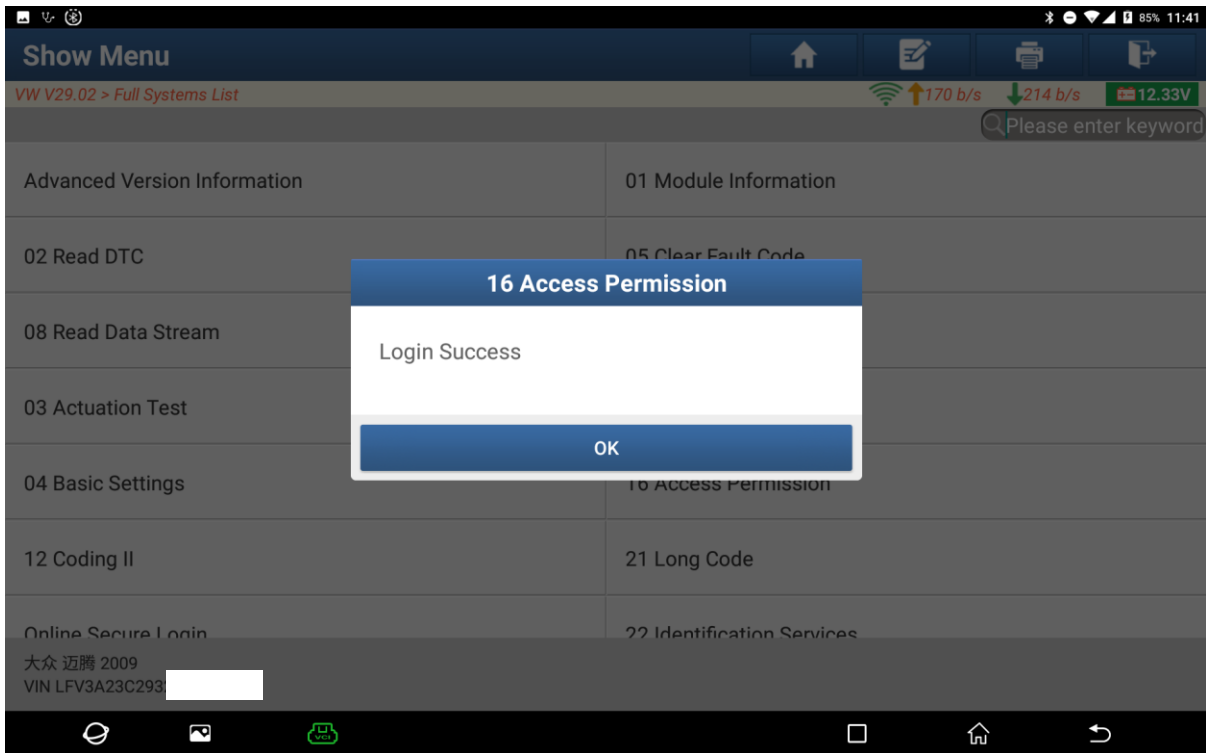
Figure 5

5. Login is successful. Click OK. (See the following figure.)

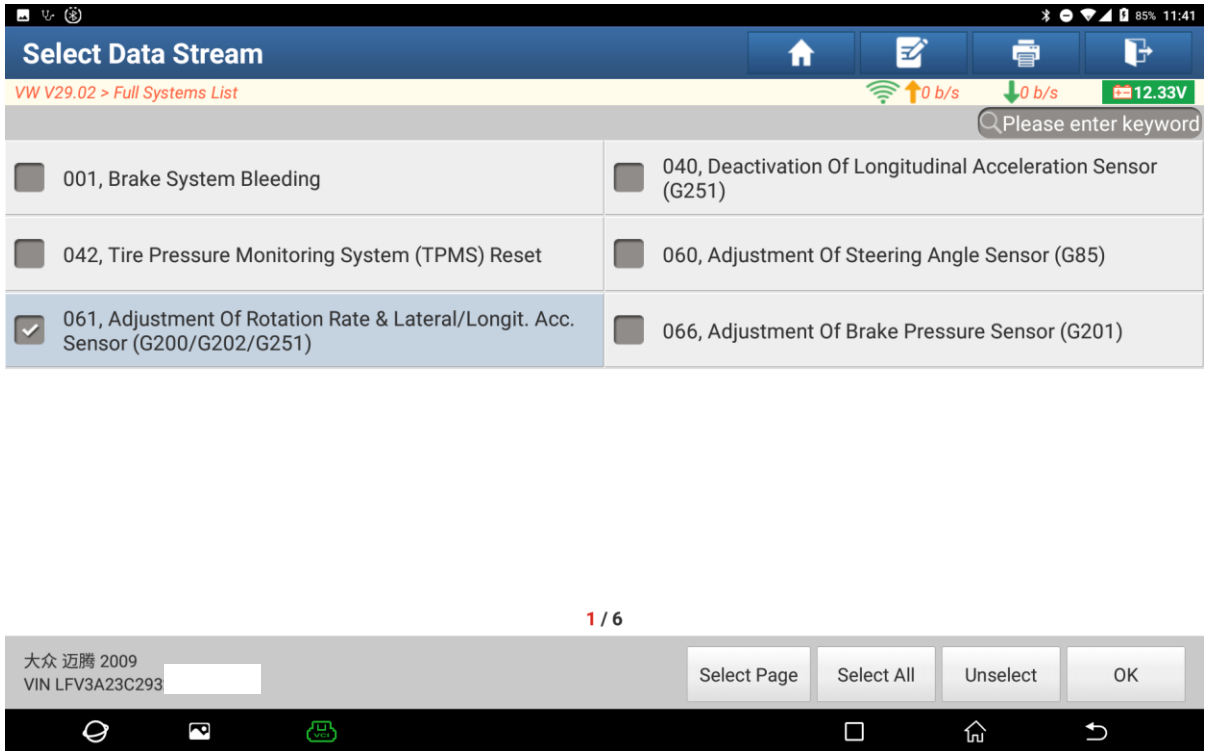
Figure 7

7. Choose [061, Adjustment of Rotation Rate & Lateral/Longit. Acc. Sensor (G200/G202/G251)]. (See the following figure.)

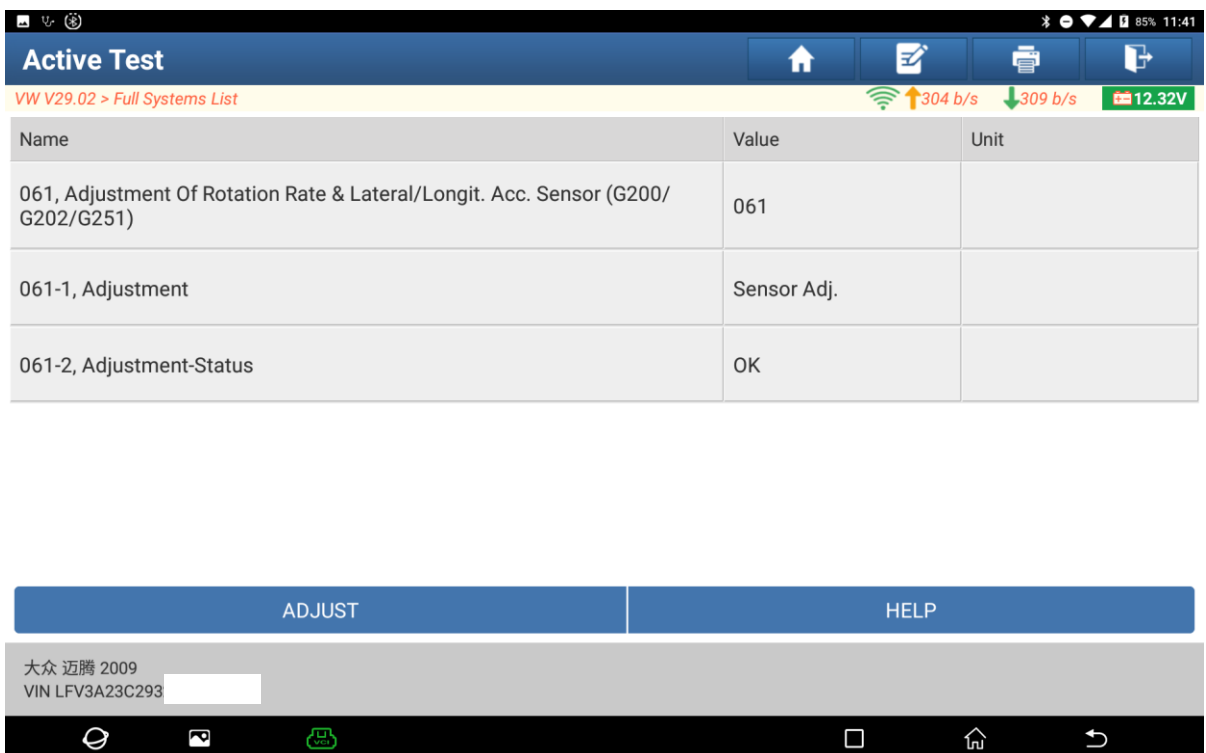
Figure 8

8. Click [Adjust]. (See the following figure.)

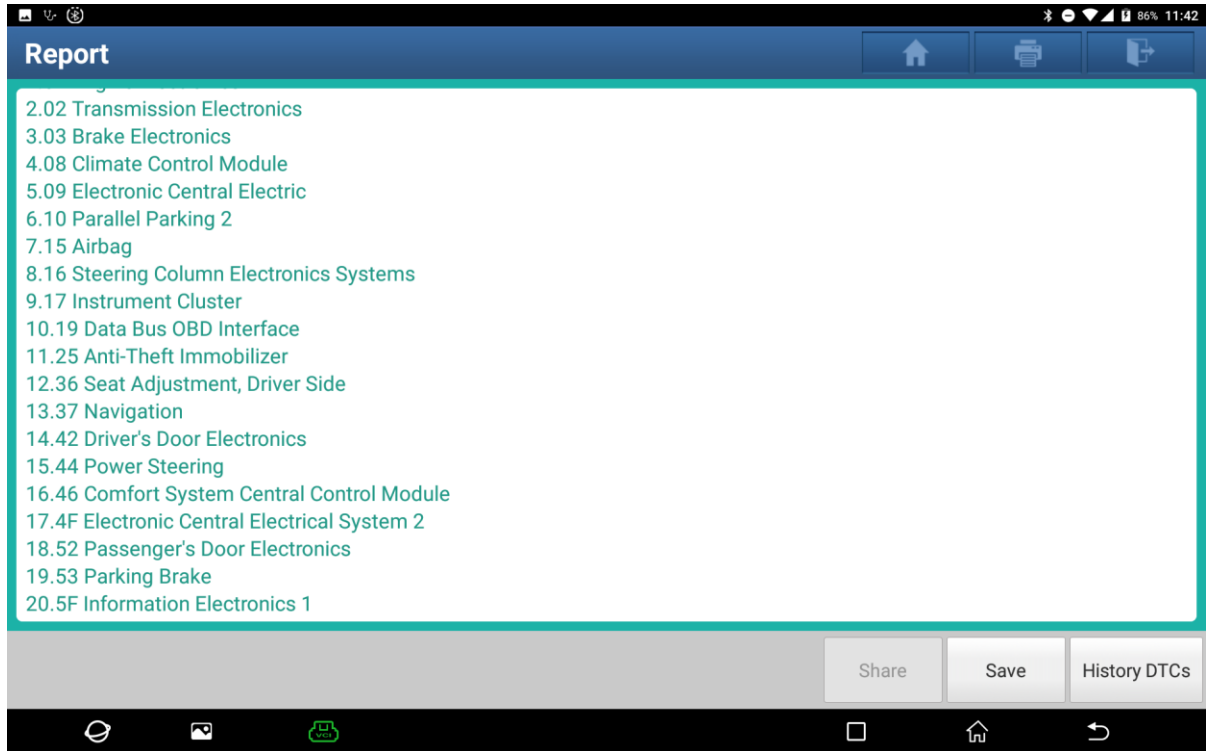
Figure 9

9. Save the fault report. The 53 parking brake has no DTC. (See the following figure.)
